CABRAMATTA LOOP PROJECT

AUSTRALIAN RAIL TRACK CORPORATION

CONSTRUCTION MONITORING REPORT

November 2021

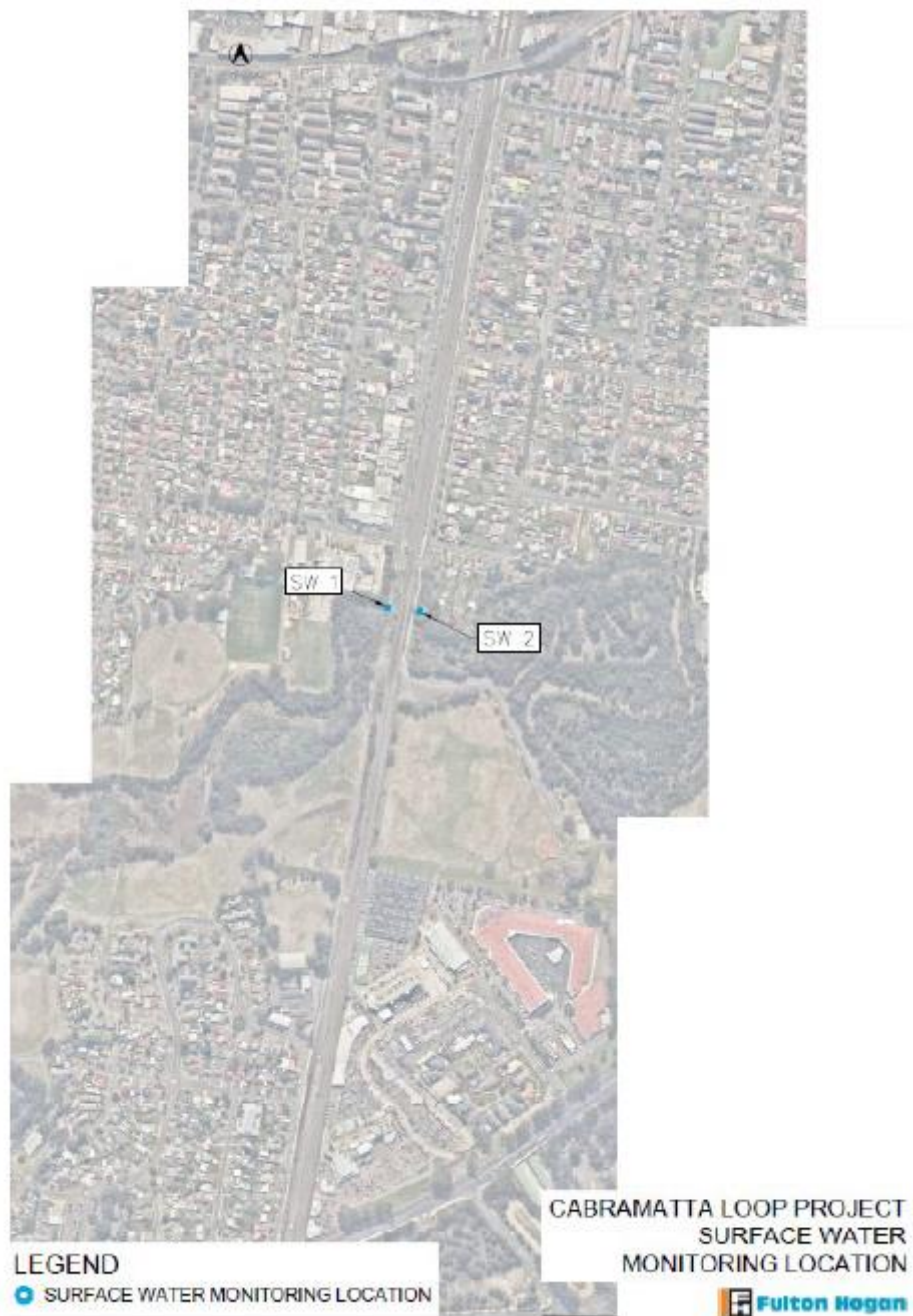
Figure 1 – Indicative water quality monitoring locations

Figure 1: Construction Water Quality Monitoring Locations

Date	Location	Co-ordinates	pH	NTU (Field)	Oil & Grease
27/11/2021	CLP U/S	-33.90260° 150.93804°	6	19.7	Not visible
27/11/2021	CLP D/S	-33.90403° 150.93851°	6	19.6	Not visible
