CABRAMATTA LOOP PROJECT

AUSTRALIAN RAIL TRACK CORPORATION

CONSTRUCTION MONITORING REPORT

May 2022 to October 2022

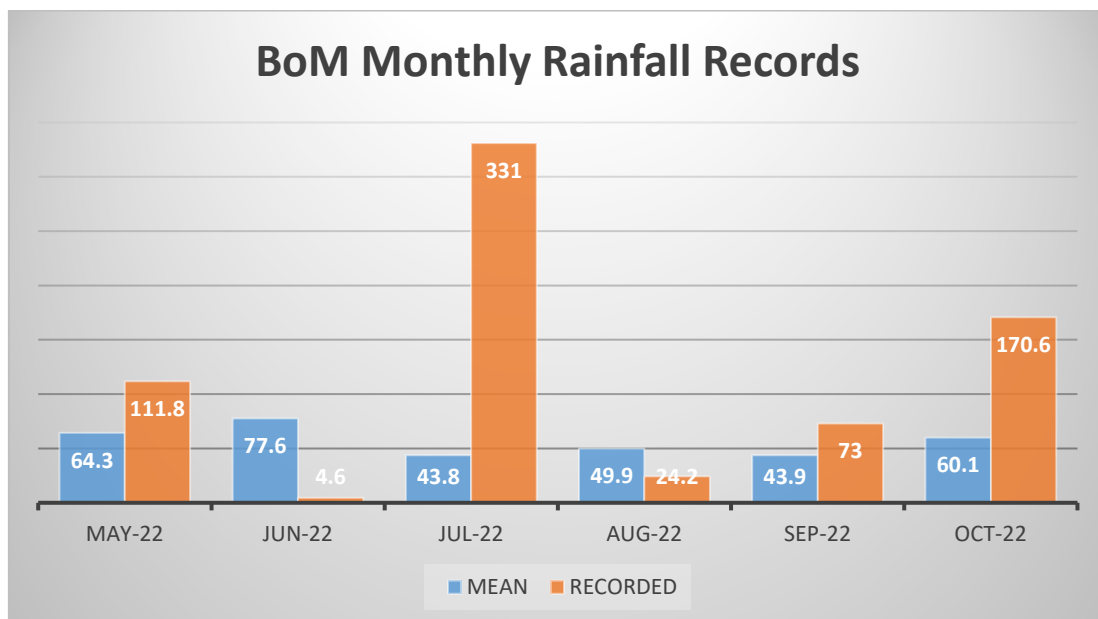
Above: Rainfall data from the nearest Bureau of Meteorology station at Bankstown Airport vs statistical mean records

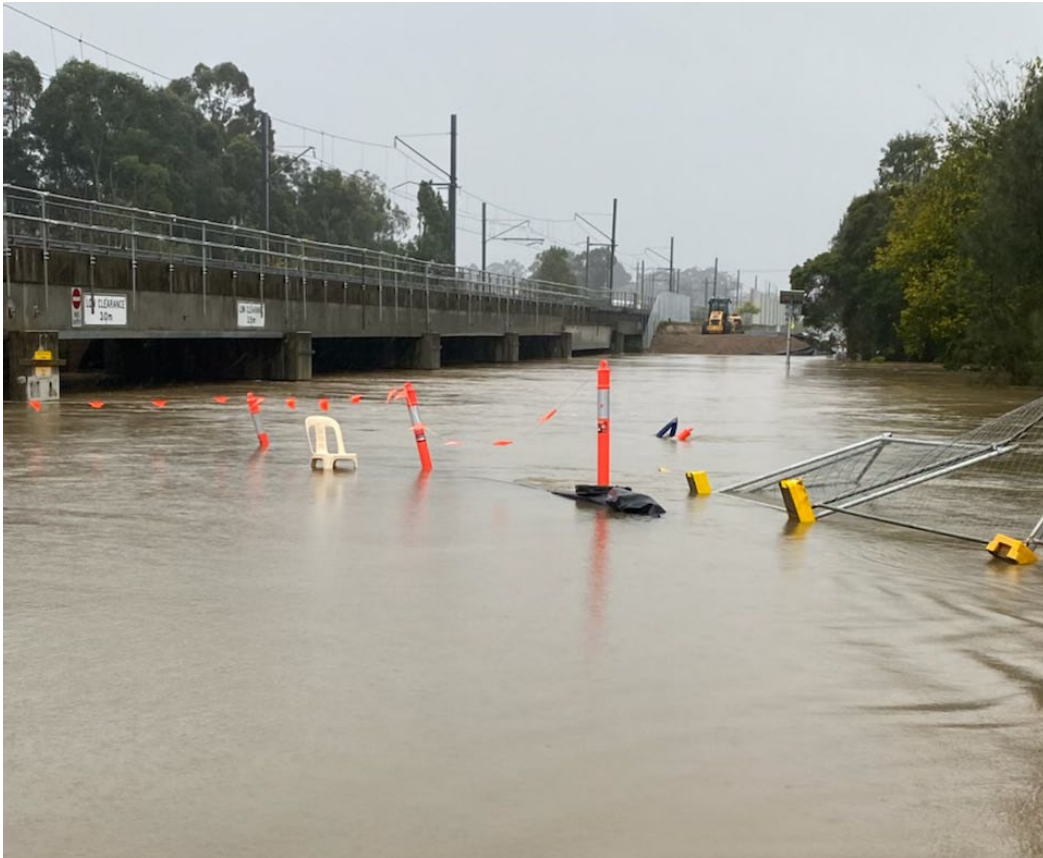
Above: July Floods at Cabramatta Rail Loop 2022

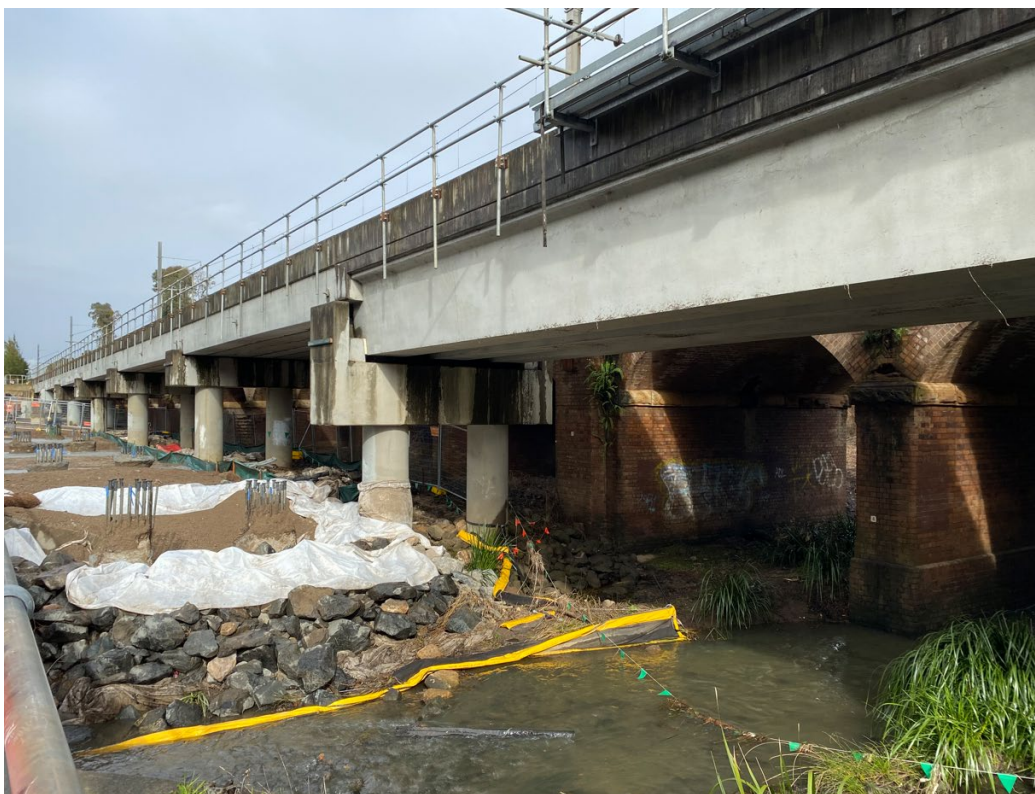
Above: Piling pad establishment at Cabramatta Creek during the end of July

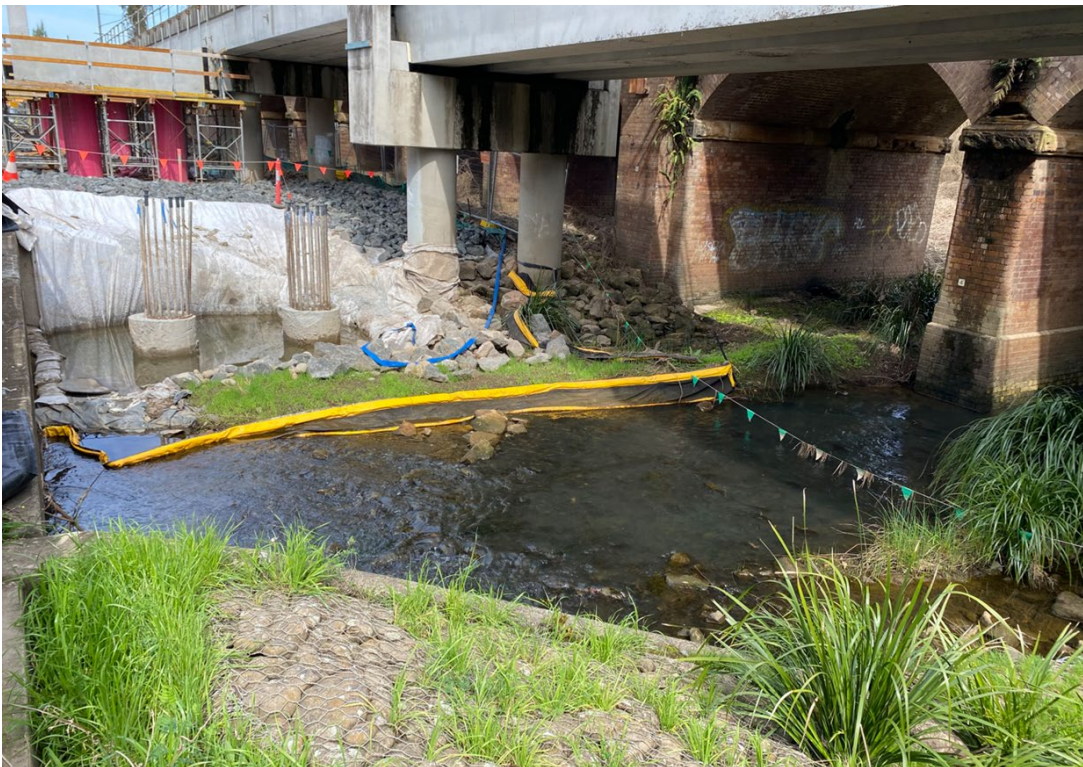
Above: Progression of piling and bridge works at Cabramatta Creek during September

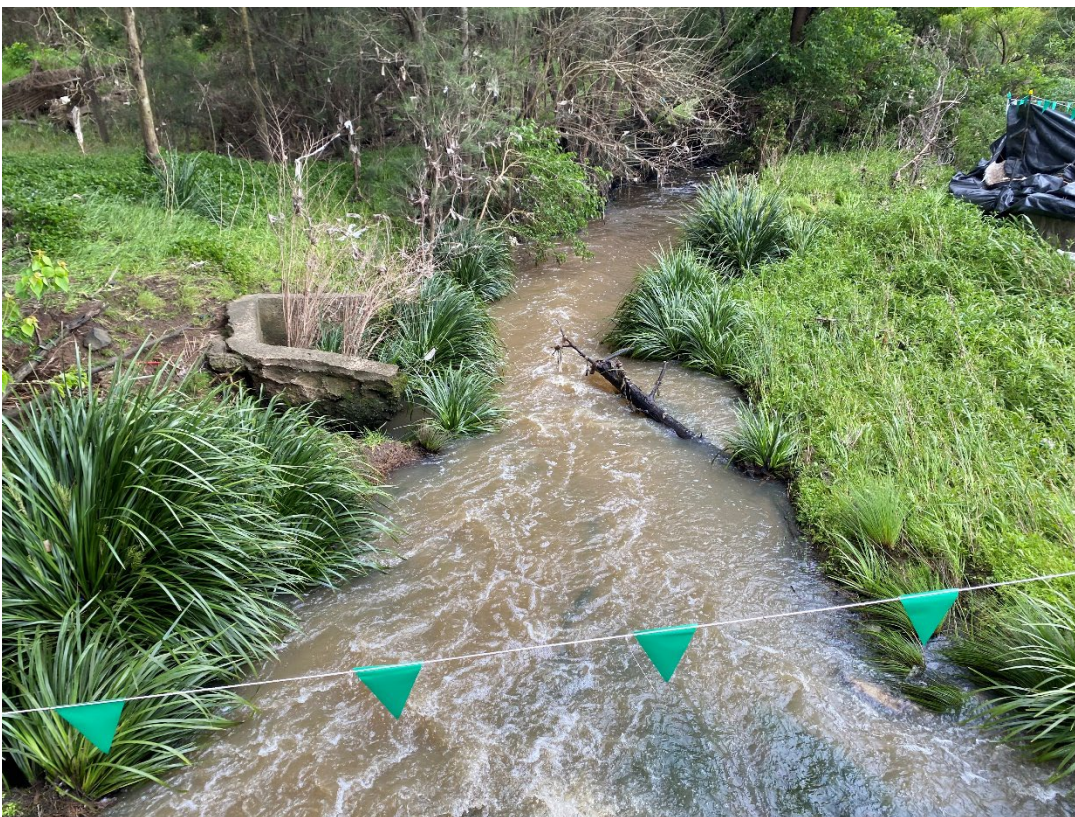
Above: Looking downstream of Cabramatta Creek following a minor rainfall event in October

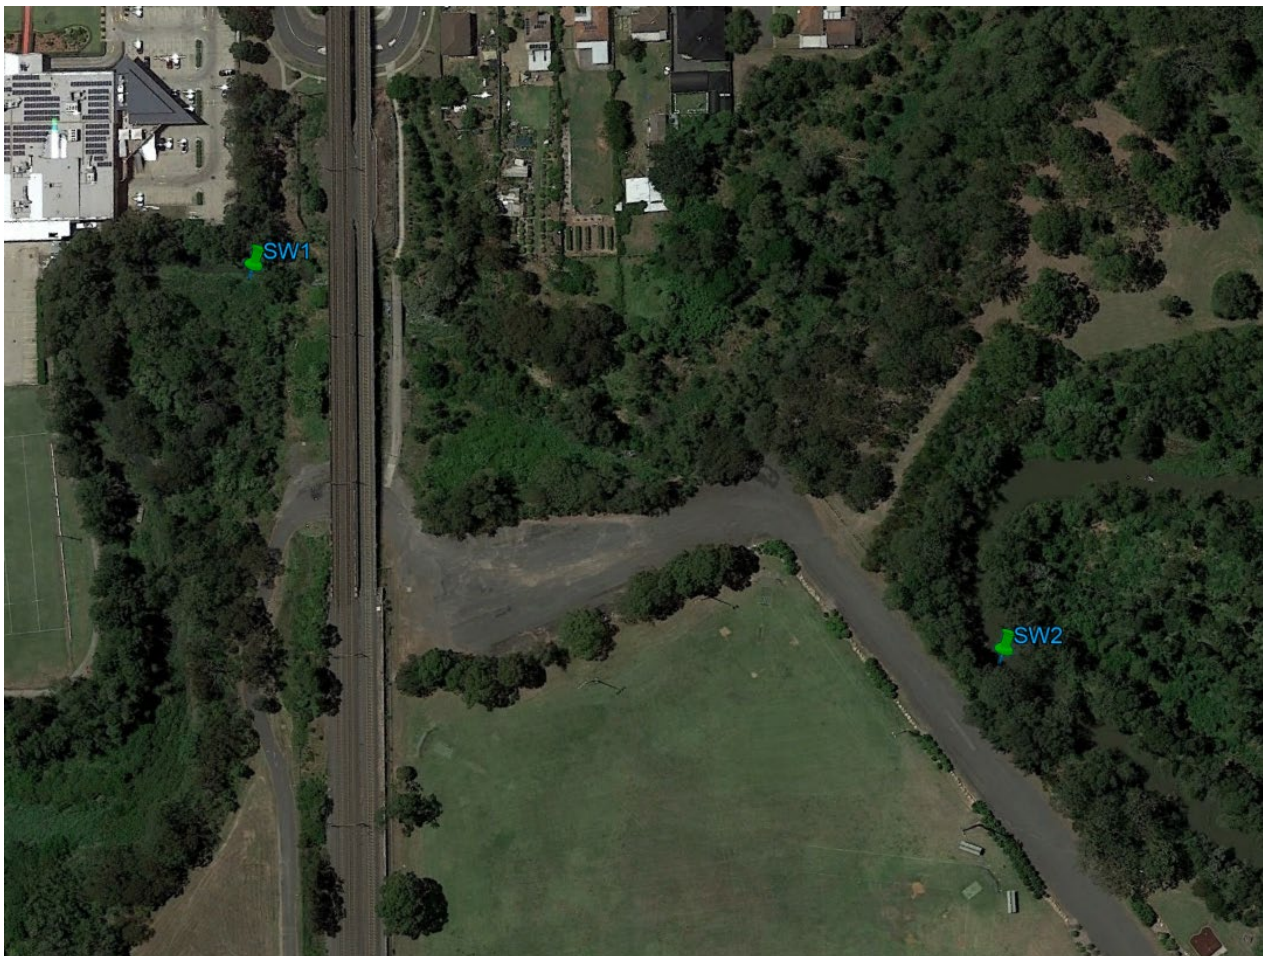
Figure 1 – Indicative water quality monitoring locations

The two construction water quality monitoring locations are indicated below as SW1 (Upstream) and SW2 (Downstream). The sampling sites were moved from those recommended by GHD in advance of construction occurring based on the following assessments:

SW1 (Upstream) was identified as the safest access immediately west of the existing rail bridge over Cabramatta Creek. This is downstream of GHD’s recommended location and picks up additional major urban inflows from a box culvert draining from the west adjacent Cabramatta Sports Grounds containing runoff from parts of Sussex Street (west), Jasmine Crescent and Begonia Avenue and two pipe culverts draining to a headwall just west of the rail bridge crossing, draining parts of Sussex Street (west), Church Street and Railway Parade. Without relocating this upstream monitoring location, any pollutants associated with urban runoff may have been thought attributable to the construction phase of the project.

SW2 (Downstream) was identified as the safest access immediately east of the existing shared user culvert crossing over Cabramatta Creek. Firstly, the site nominated by GHD as Downstream

(Broomfield Street cycleway) did not adequately capture potential runoff that could drain into Cabramatta Creek from the piling and crane pads associated with construction of the Cabramatta Creek rail bridge or the potential runoff from the laydown area adjoining Jacqui Osmond Reserve. During May, the project identified a potential new downstream location that took advantage of a previously cleared section of embankment associated with a pumping station to provide safe access to the waterway where potential hazards such as steep embankment, rock and woody debris trips and snakes can be easily identified without impacts to riparian flora. Following a major flooding event, along with antisocial behaviour of a vagrant living at the pumping station, it was determined unsafe to continue monitoring at this location and a contingency location was identified further downstream for times when safety of monitoring staff could not be guaranteed. See Figure 1 and below images for details.

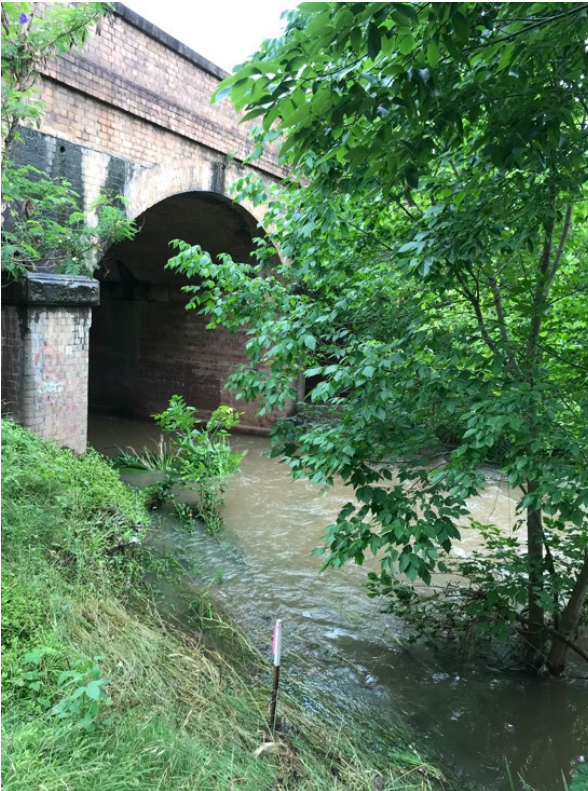
Above:
Upstream Surface Water Sampling Point SW1
Latitude: -33.90260 °
Longitude: 150.93804
November 2021

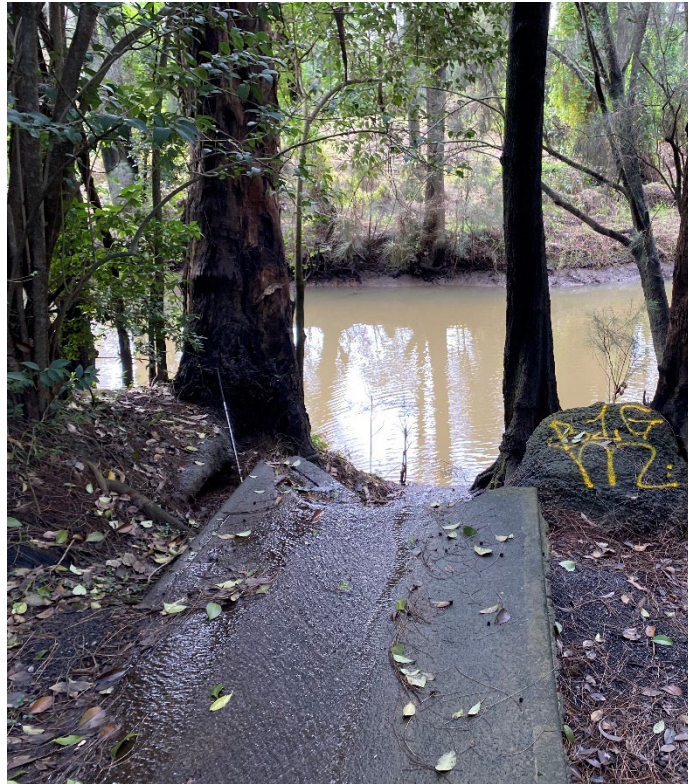
Above:
Downstream Surface Water Sampling Point SW2
Latitude: - 33.541814°
Longitude: 150.562122°
May 2022

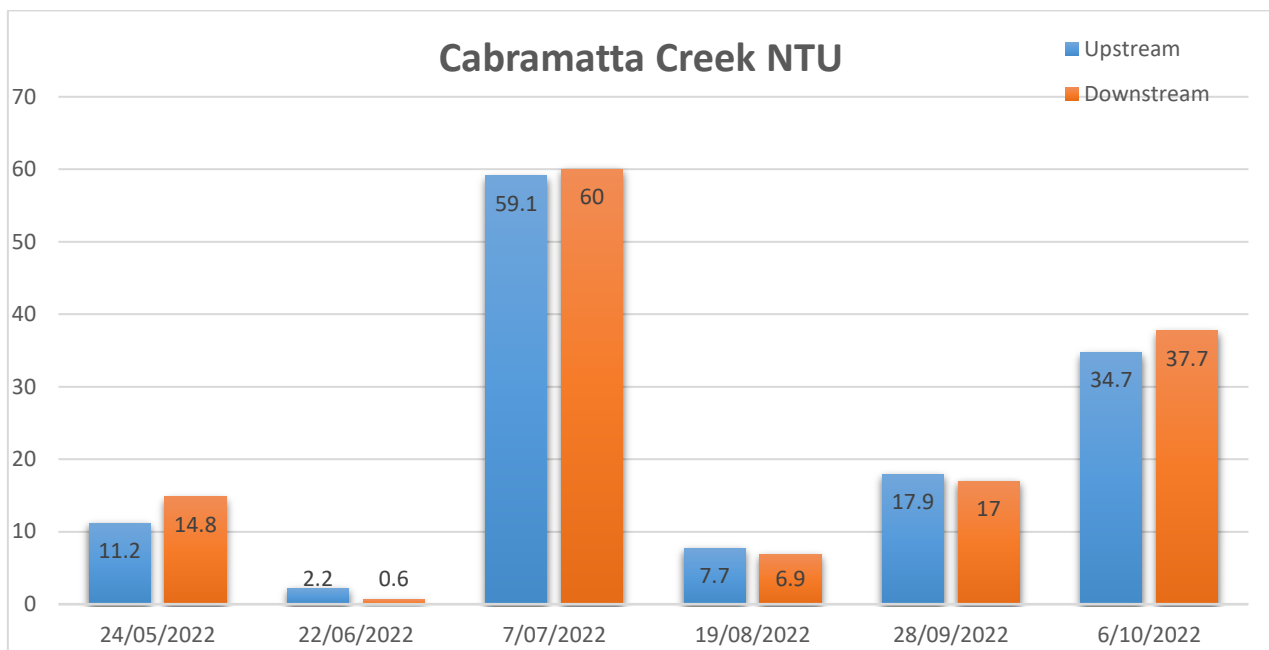
Above: Turbidity data from Table 1 graphed demonstrating monthly trends

- No oil or grease was observed as visible during any sampling event.
- In all months bar July, the turbidity recorded at both the upstream and downstream sites was below the 50 NTU NSW Water Quality Objective Criteria. In June, turbidity was recorded below the lower guideline of 6 NTU. Extremely clear water can signify very acidic conditions or high levels of salinity however these results are consistent with baseline monitoring data where GHD previously reported "*A number of samples at all sites were below the lower guideline, this was attributed to the salinity of the sites as recorded in the EC present. Whilst these samples are regarded as outside the*"

guideline range, the low turbidity can be expected due to natural processes present at the sites.” In relation to levels ranging from 6.9 to 60 NTU, these values are consistent with baseline maximums where GHD has commented “these results are as expected in wet weather flows through areas where urbanisation through the catchment has occurred, as it has in much of the Cabramatta Creek catchment.”

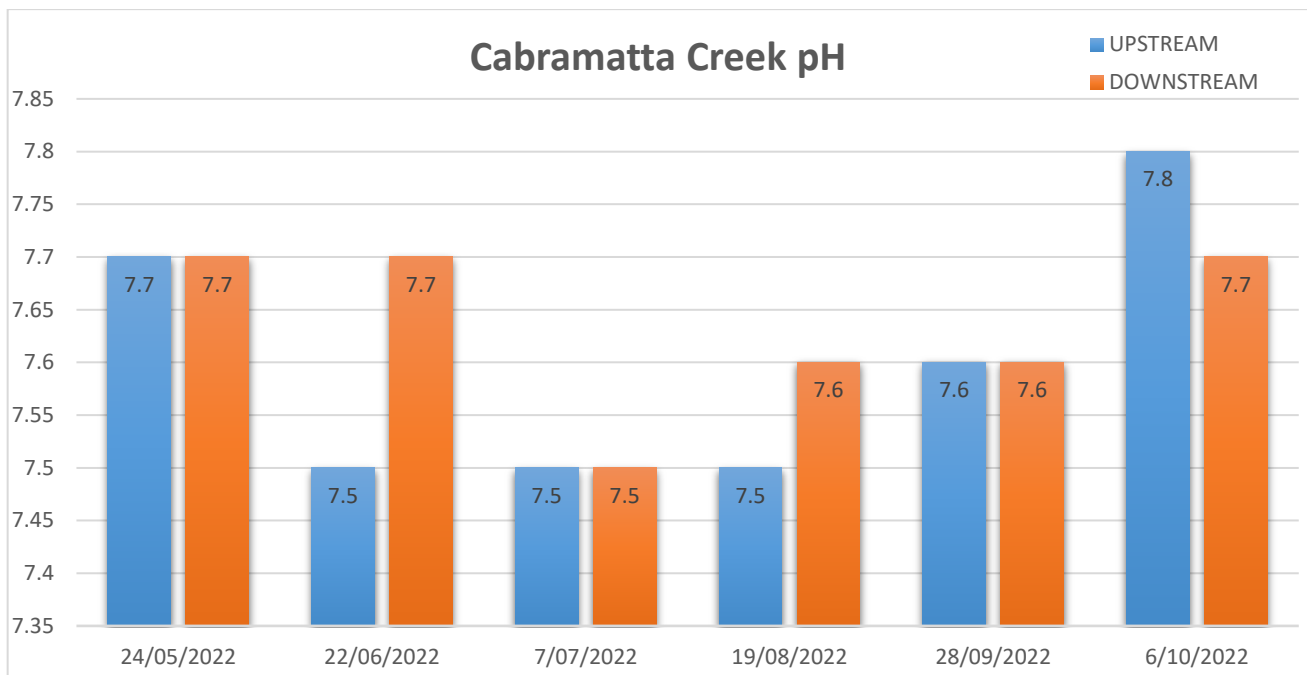
Above: pH data from Table 1 graphed demonstrating monthly trends

- pH was always within the ANZECC guideline range, with a high end of 7.8 pH and a lower end of 7.5 pH.
- Based on the available data and field observations, the construction phase environmental controls and management measures implemented during the six month period have been effective in meeting the project’s water quality objectives and minimising impacts to the Cabramatta Creek and Georges River ecosystems.

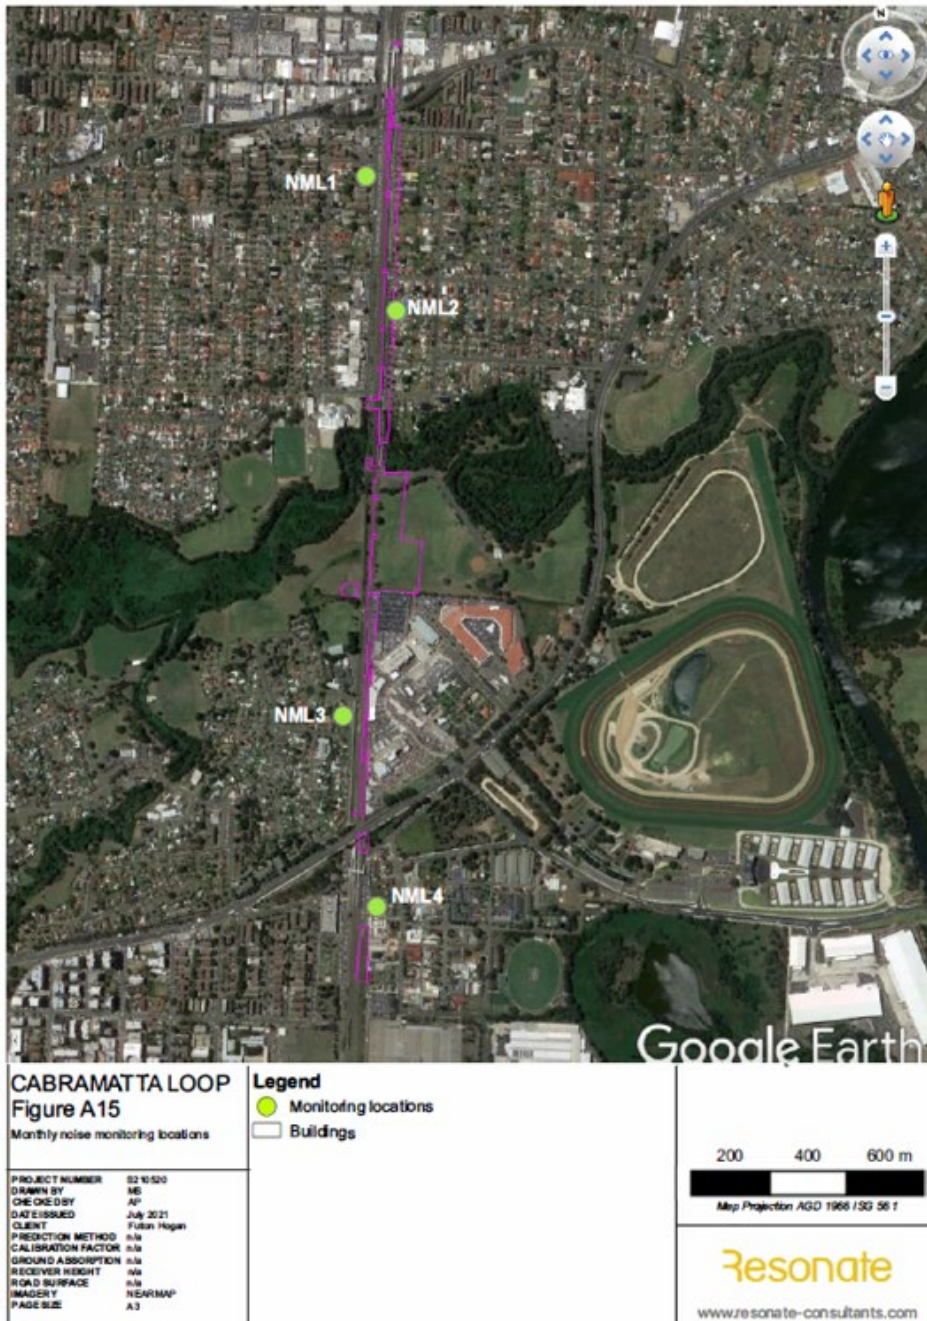
Figure 3 – Indicative noise monitoring locations

- Location 1: 225 Railway Parade, Cabramatta
- Location 2: 150 Broomfield Street, Cabramatta
- Location 3: Corner of Station Street and Lawrence Hargrave Road
- Location 4: In railway corridor north of Warwick Farm Station

The monitoring locations were selected to cover each NCA and proximity to key construction zones and most potentially affected sensitive receivers.

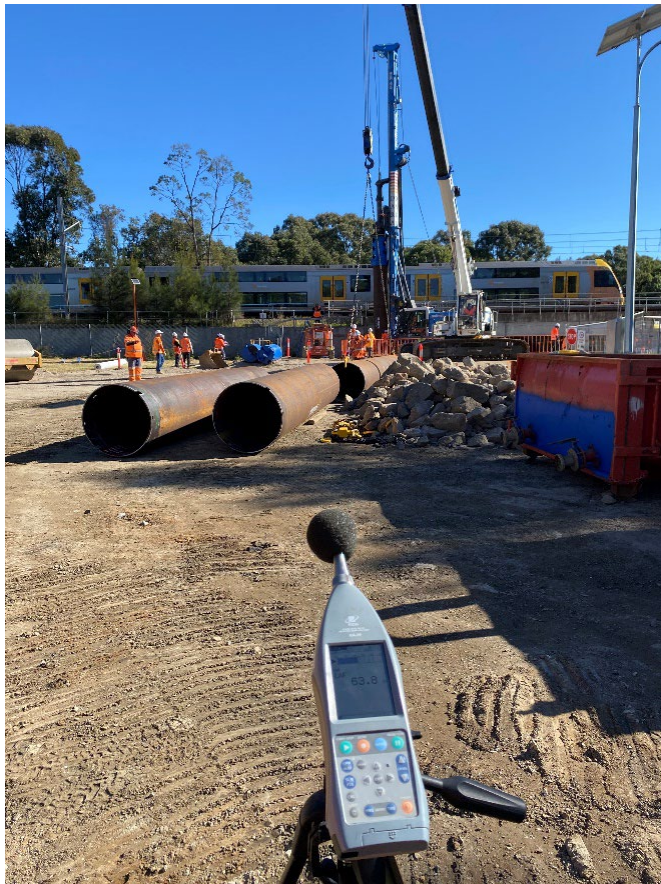
Spot check	JOR compound – Northern Laydown area	Test monitoring of piling rig	9/6/2022	N/A	N/A	Spot test indicated noise level at approximately 63dB during auguring.

Above: Test monitoring of piling rig on the 9th June 2022, weeks prior to works near the sensitive receivers at Sussex Street and along Broomfield Street.

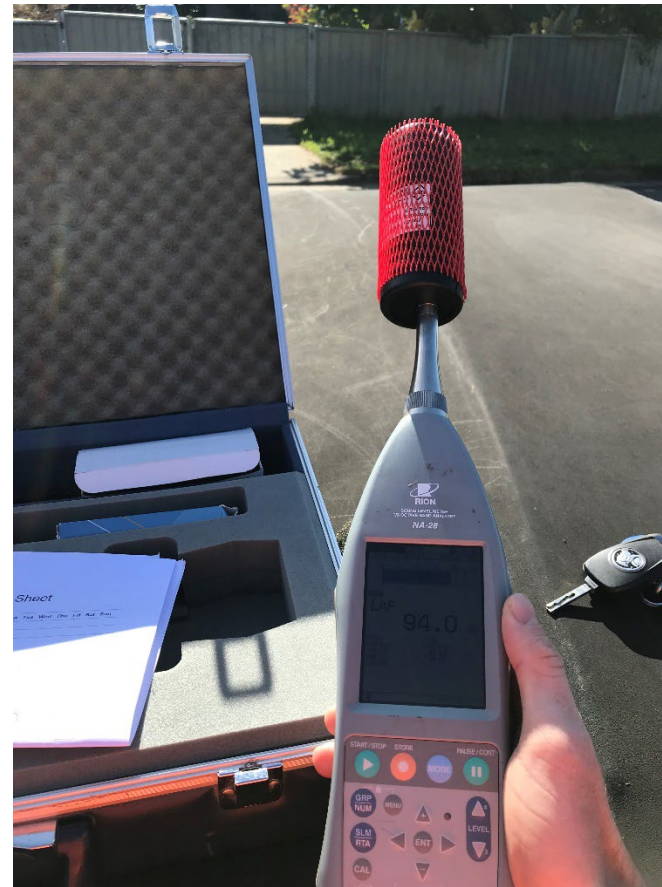
Above: Calibrating the machine at 94 dB(A) before monitoring in June.

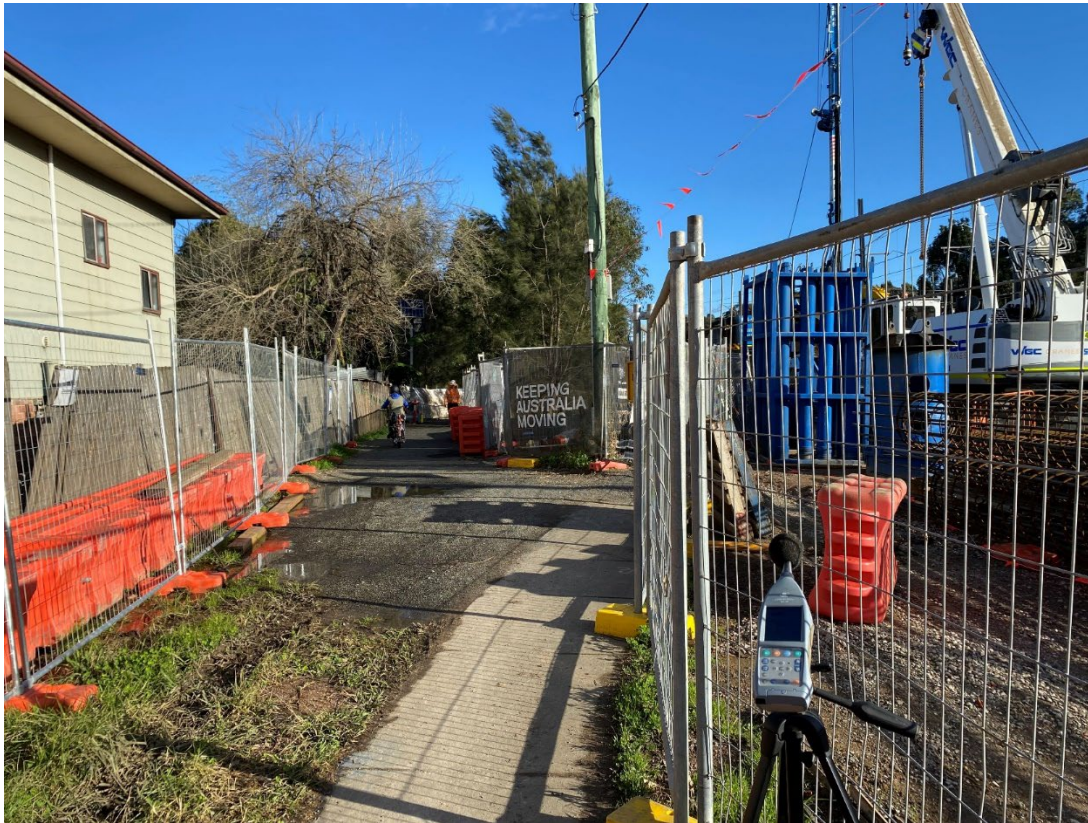
ID# / NCA	Location	Reason for monitoring	Date/Time	RBL dB(A)	L(A) _{eq(15min)} dB(A)	Comments
Spot check	10 Sussex St, Cabramatta	Monitoring to determine potential noise impacts at most sensitive receiver during piling	26/7/22	N/A	62	<p>Lmax – 71 Lmin – 52 L10 – 65 L90 – 60</p> <p>4 x passing LVs @ 55-61dB 1 x overhead aircraft for 20 secs @ 59-65dB 6 x Syd trains for 10-15 secs @ 63-68dB Piling rig auguring in hole @ 60-63dB 2 x piling rig quacker for 3 secs @ 59-65dB Piling rig idling @ 52-54dB 3 x dog barks nearby @~60dB</p>
Spot check	10 Sussex St, Cabramatta	Monitoring to determine potential noise impacts at most sensitive receiver during piling break-back	27/7/22 12:19	N/A	58	<p>Lmax – 70 Lmin – 48 L10 – 61 L90 – 51</p> <p>1 x Passing heavy vehicle with beeper @ 52-55dB 6 x overhead aircraft for 30-45 secs @ 51-61dB 2 x Syd trains for 10 secs @59-65dB 1x small freight train for 16 secs @63-68dB Pile break-back for 80% of monitoring @55-61dB Excavator idling on RW10 pile @50dB</p>

Above: Spot check at 10 Sussex St during piling activities in July

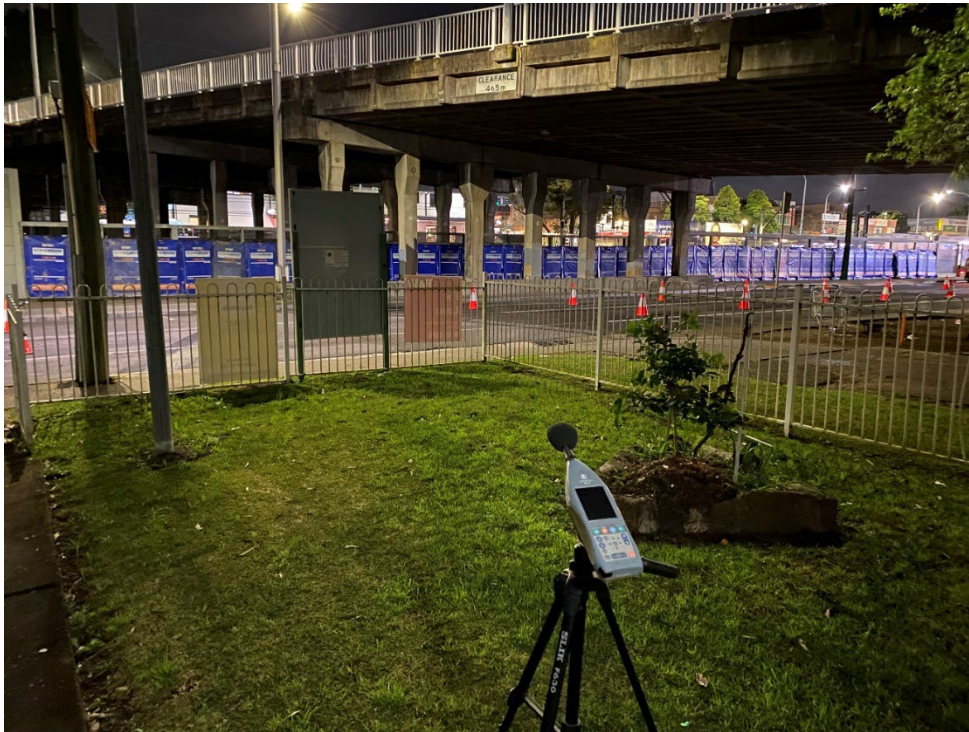
Above: Monitoring during WE10 possession on the 2nd September 2022

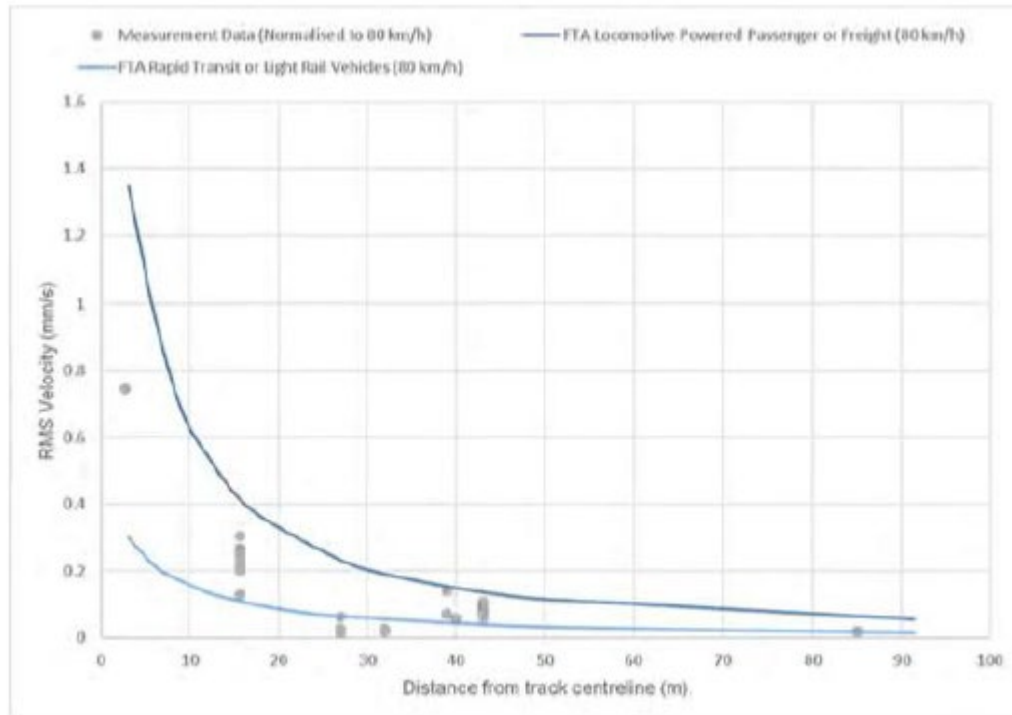
During the EIS assessment in 2018, attended and unattended vibration monitoring was undertaken within and outside the rail corridor. The results of the monitoring indicated 4-5 mm/s peak vibration levels 6 metres from the railway tracks and levels between 0.1 mm/s and 0.3 mm/s at the residence (150 Broomfield Street, 31 metres from the SSFL). The vibration environment was dominated by road traffic noise and intermittent rail passbys. The measured vibration levels from train passbys as presented in the EIS is shown in Figure 2. The Construction Noise and Vibration Plan commits to monitoring to confirm that works occur outside of the minimum working distances and to ensure consistency with the approved level of anticipated impacts.

Above: Excerpt from EIS - Figure 2: Baseline Vibration Monitoring Data

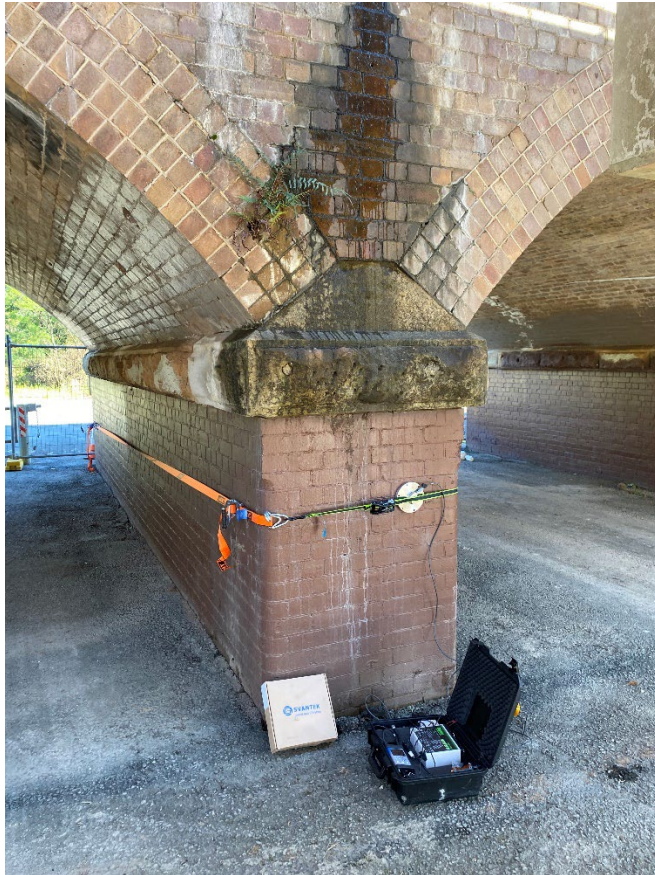
LOCATION: Heritage Bridge at Station Street

Above: Monitoring setup of the heritage bridge that carries Sydney Trains. The device was firmly strapped to the pylon during monitoring.

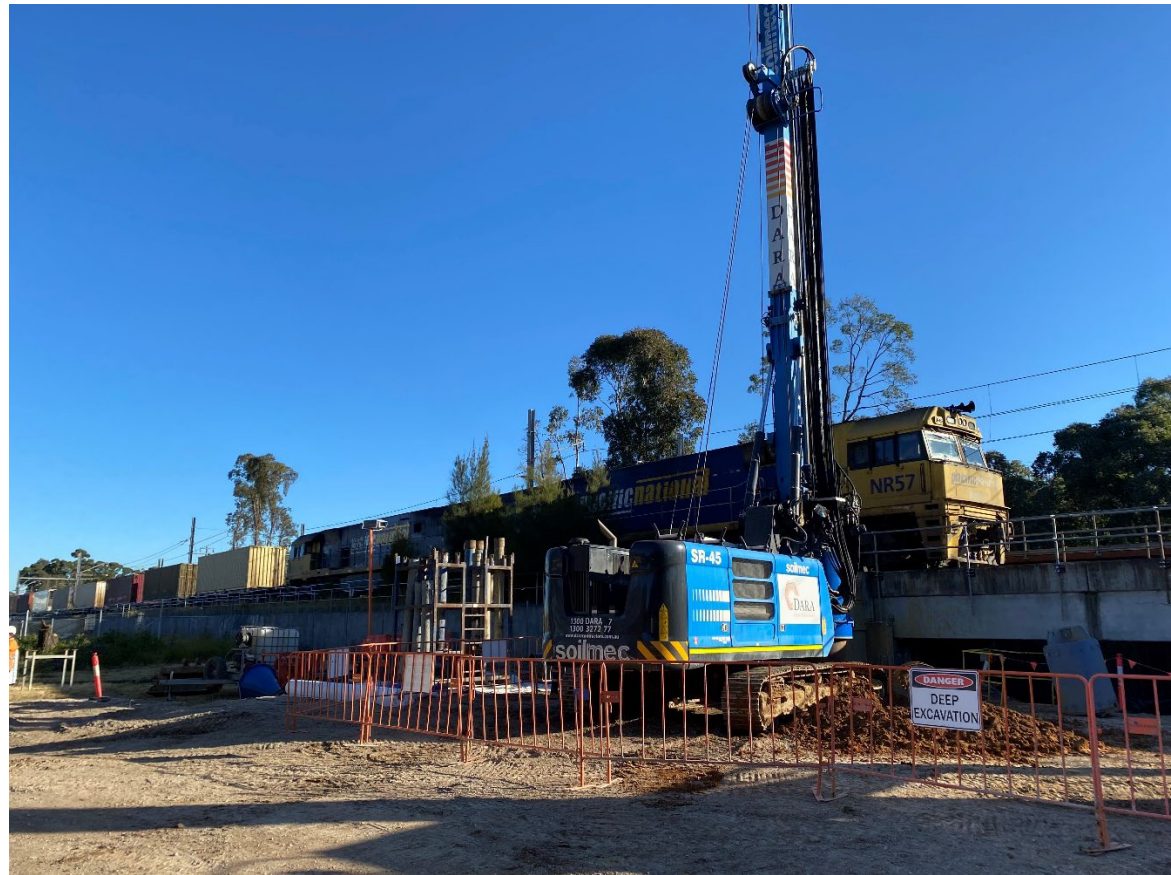
Above: Typical piling activity during monitoring in June. Piling progressed northward over the course of the month.

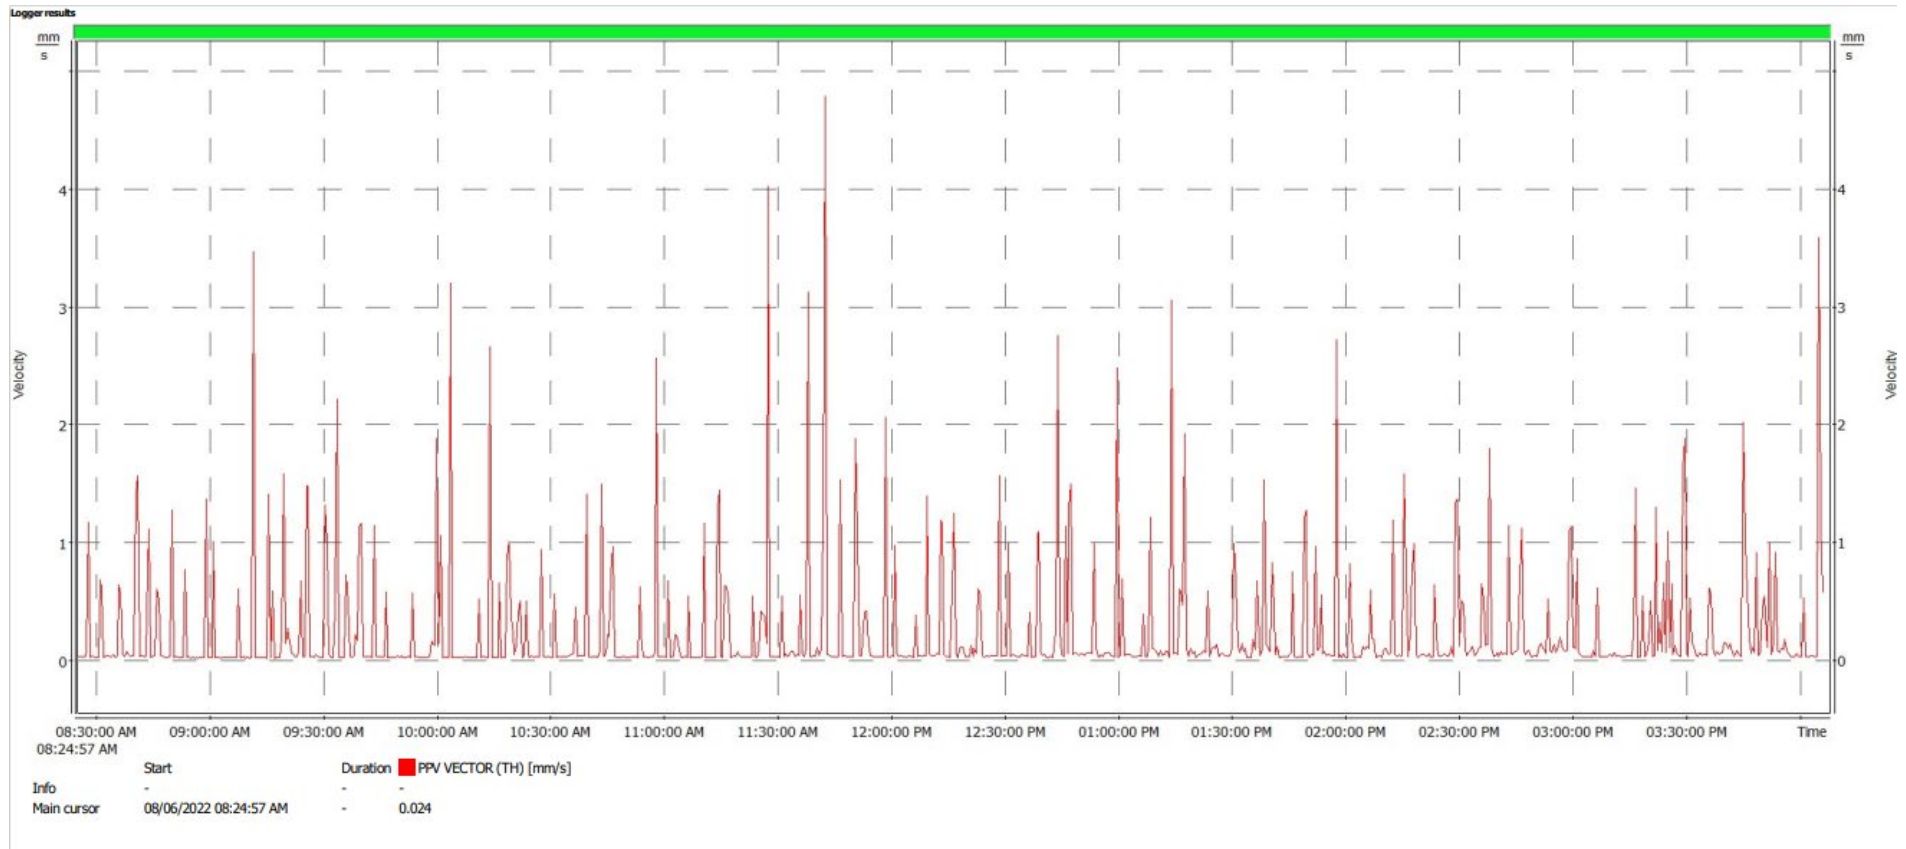
Above: Results from monitoring over 7hrs during piling at Station Street bridge on the 8th June 2022. Large and medium spikes represent the frequently passing Sydney passenger trains and SSFL freight trains. Velocity peaked at ~4.8mm/s during monitoring. The vibration from nearby piling activity was not discernible.

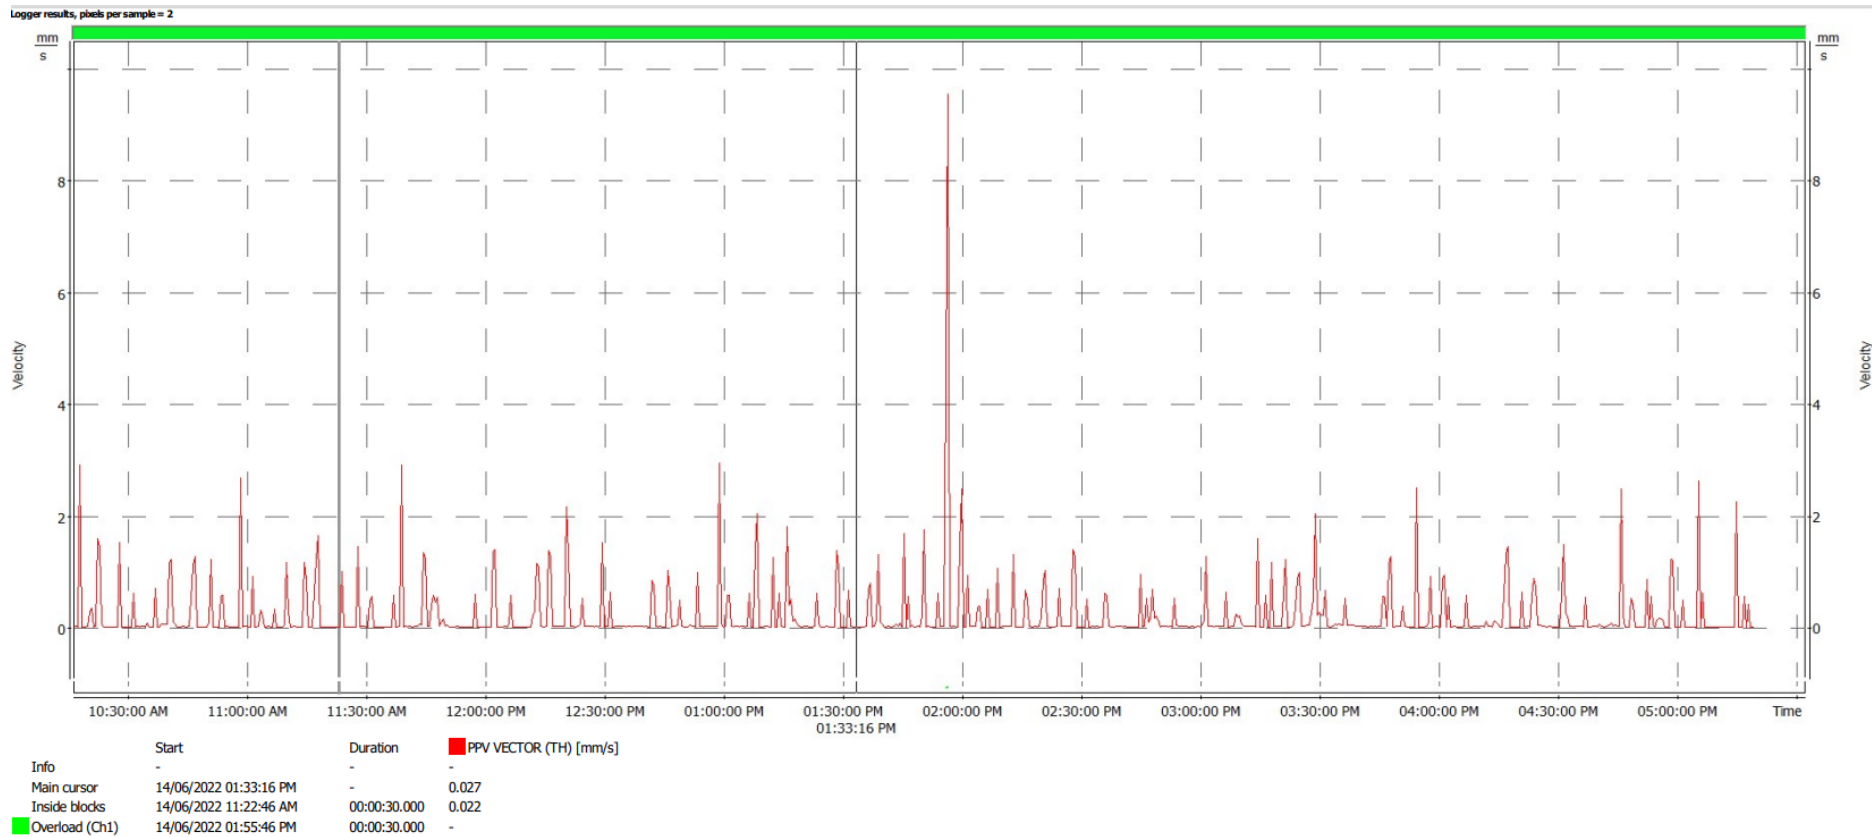
Above: Monitoring of the Station St heritage bridge over ~7hrs during piling on the 14th of June 2022. Velocity peaked at ~8.8mm/s.

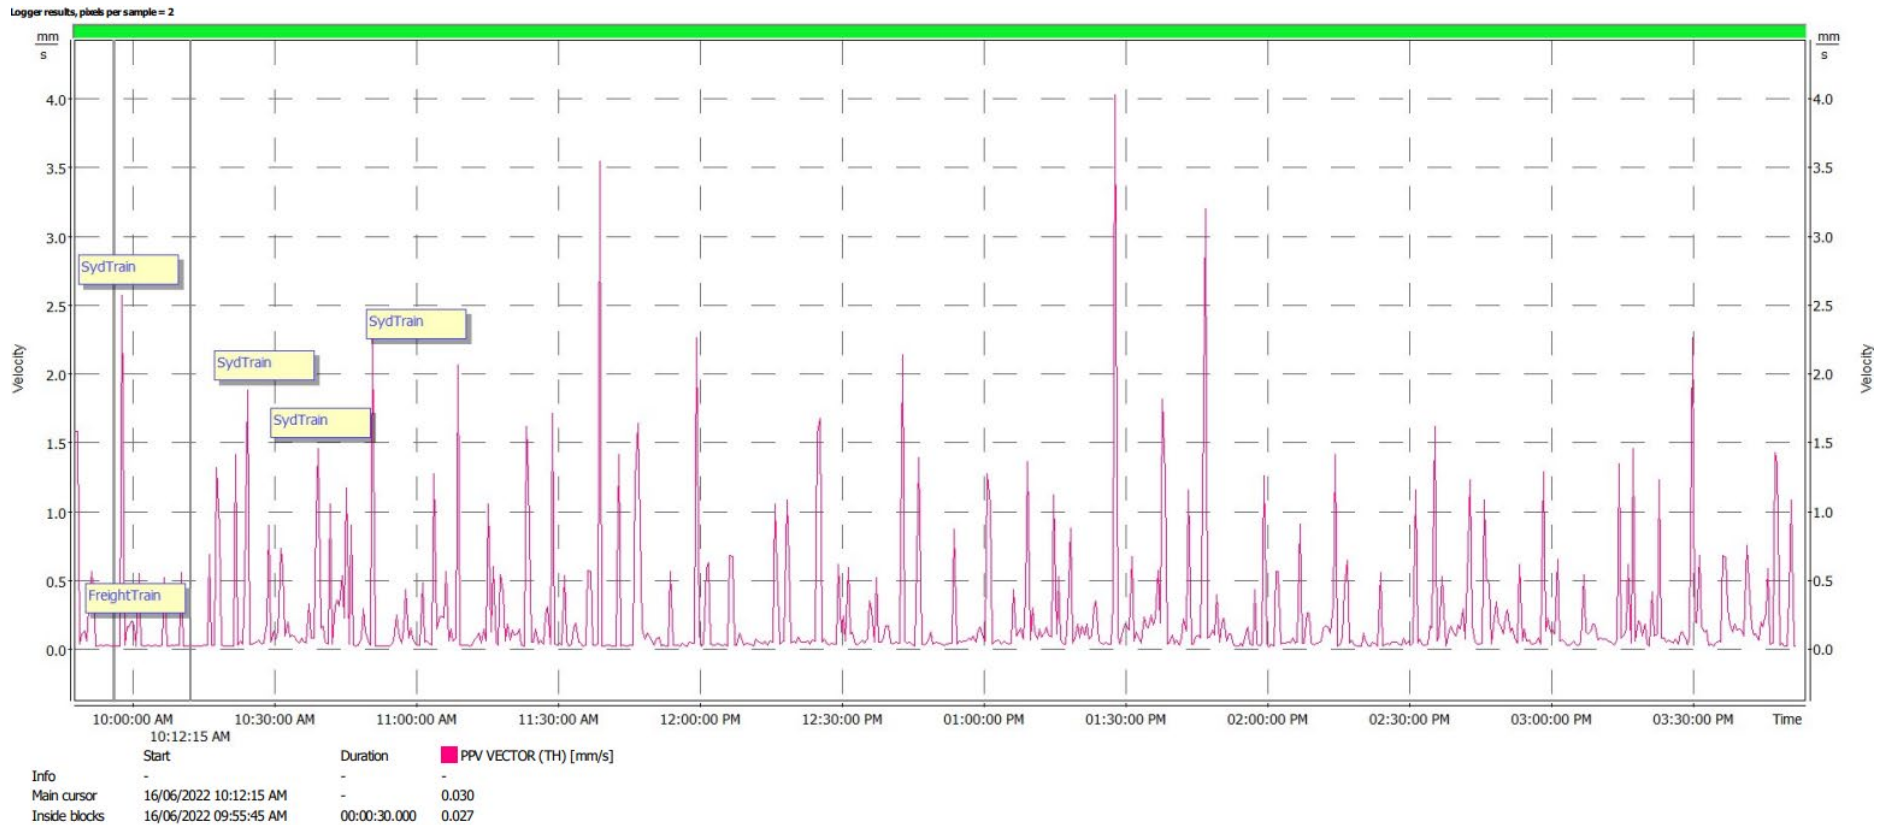
Above: Attended monitoring of the Station St arch bridge on the 16th June 2022 confirmed that the spikes in velocity are attributable to passing commuter trains – predominantly Sydney trains travelling across the bridge at moderate speeds appear to cause more vibration than the heavier, but significantly slower freight trains. Both forms of rolling stock present considerably more vibration on the bridge structure in comparison to the piling activity and this is attributable to the geology of the piling location with heavy clays comprising the bulk of the excavation with bedrock some 16-20 m below the structure.

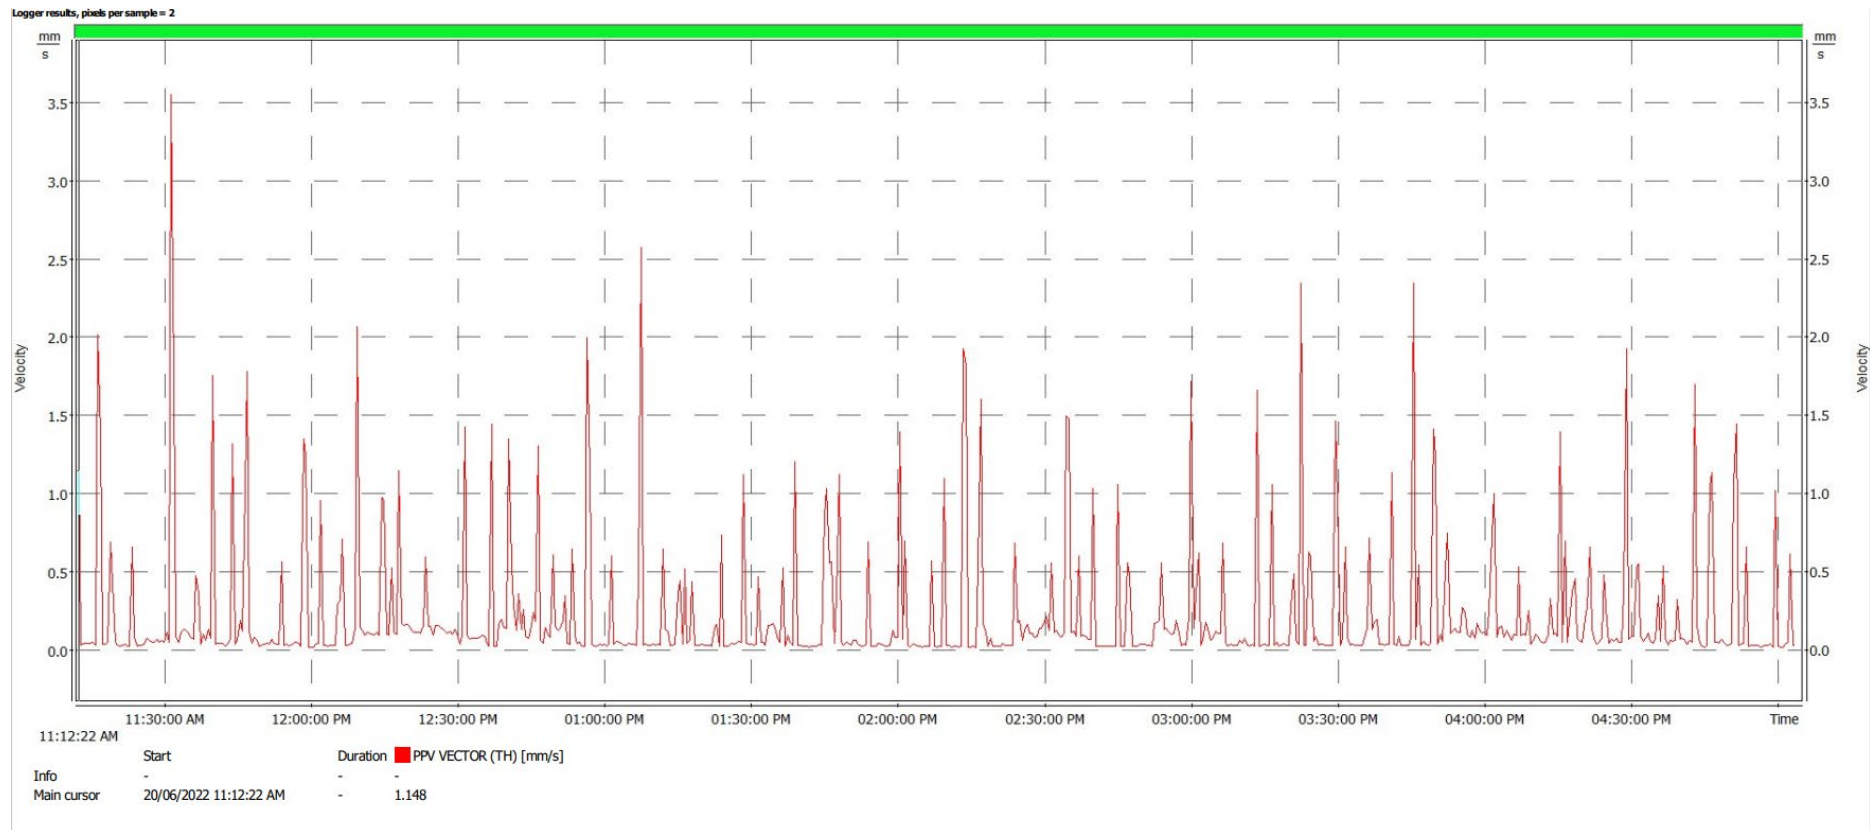
Above: Further monitoring data of Station St bridge during piling on the 20th of June 2022. Spikes and velocity is consistent with previous monitoring results.
