CABRAMATTA LOOP PROJECT

AUSTRALIAN RAIL TRACK CORPORATION

CONSTRUCTION MONITORING REPORT

May 2022 to October 2022

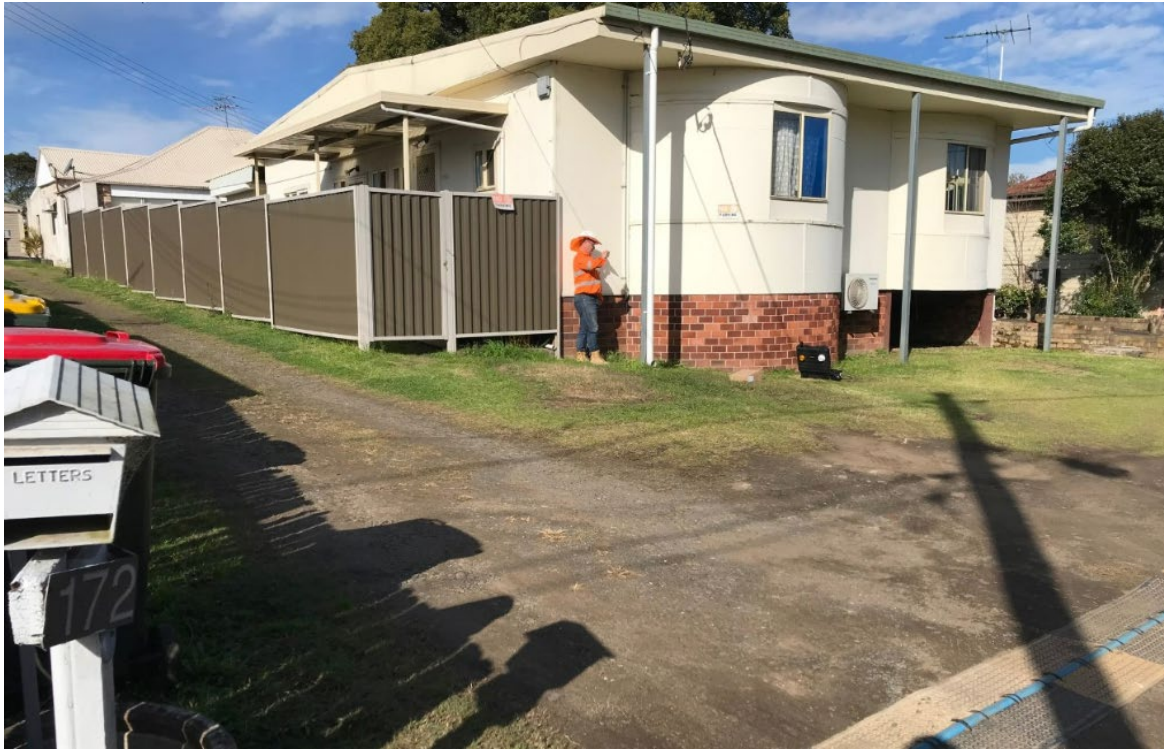
LOCATION: 172 Broomfield Street, Cabramatta

Above: Monitoring at 172 Broomfield St during compaction rolling.

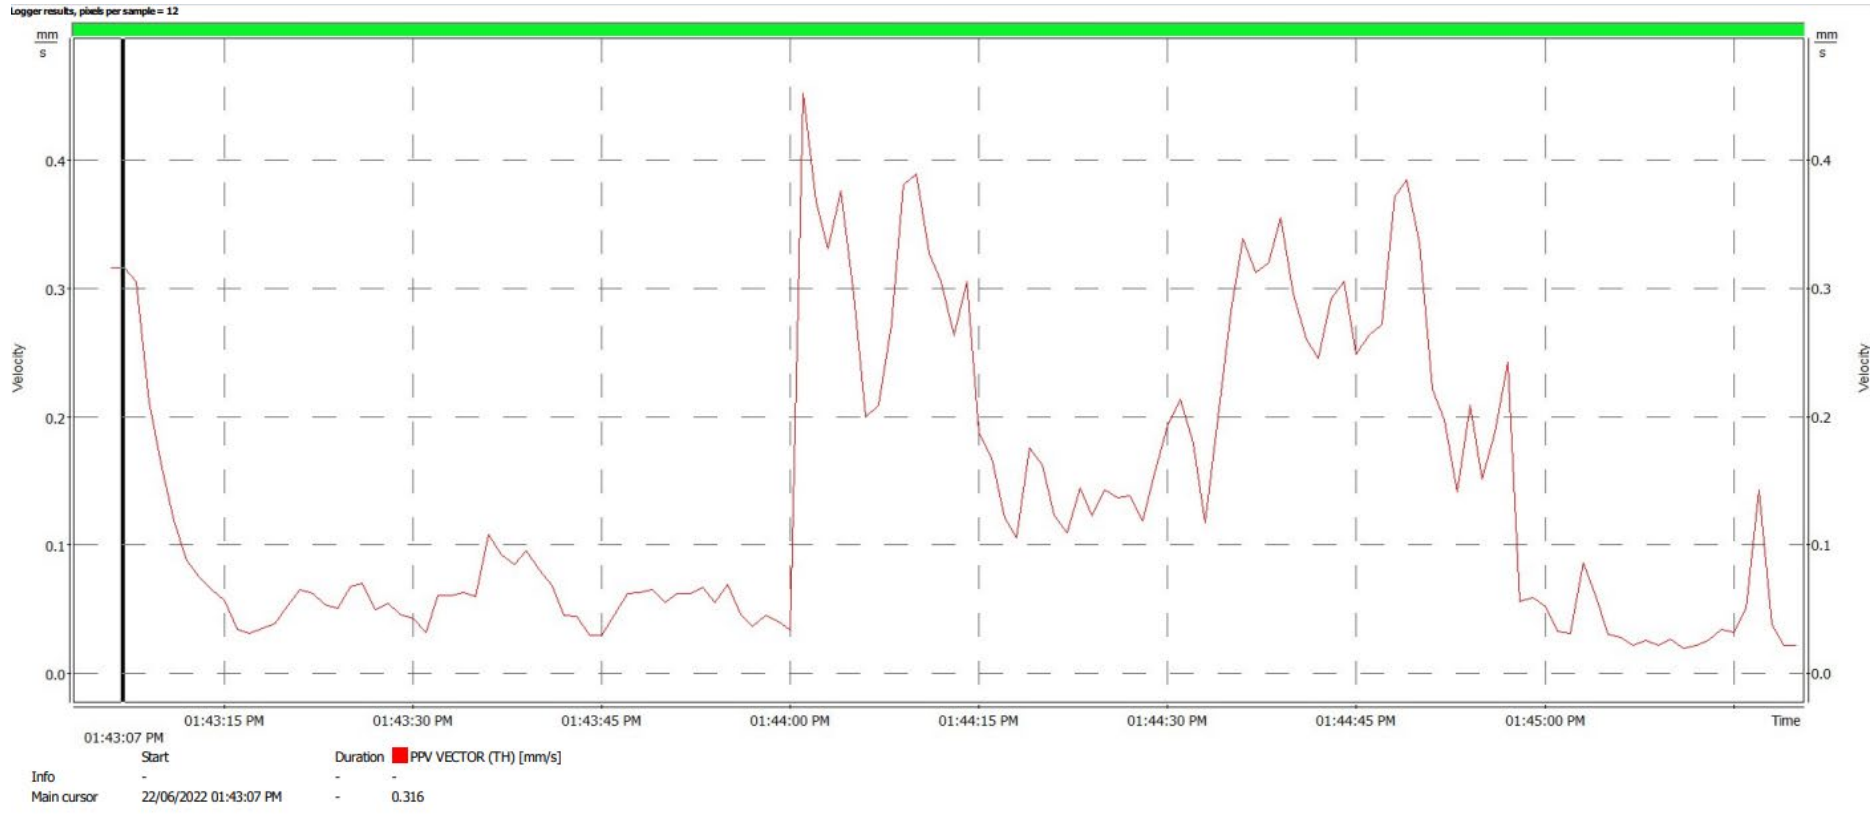
Above: Vibration monitoring of compaction roller at 172 Broomfield St on 22nd June 2022. Velocity peaked at 0.45mm/s.

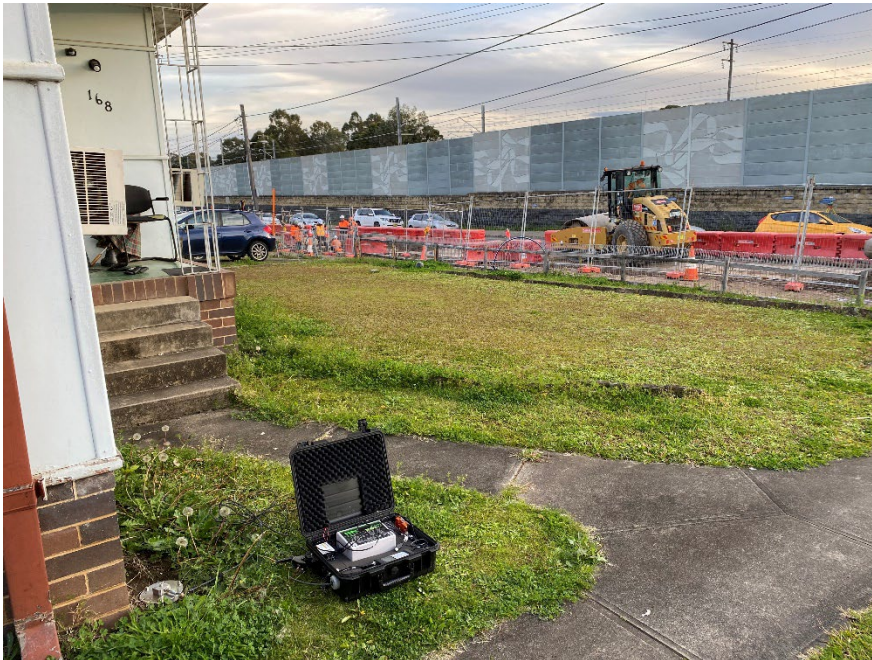
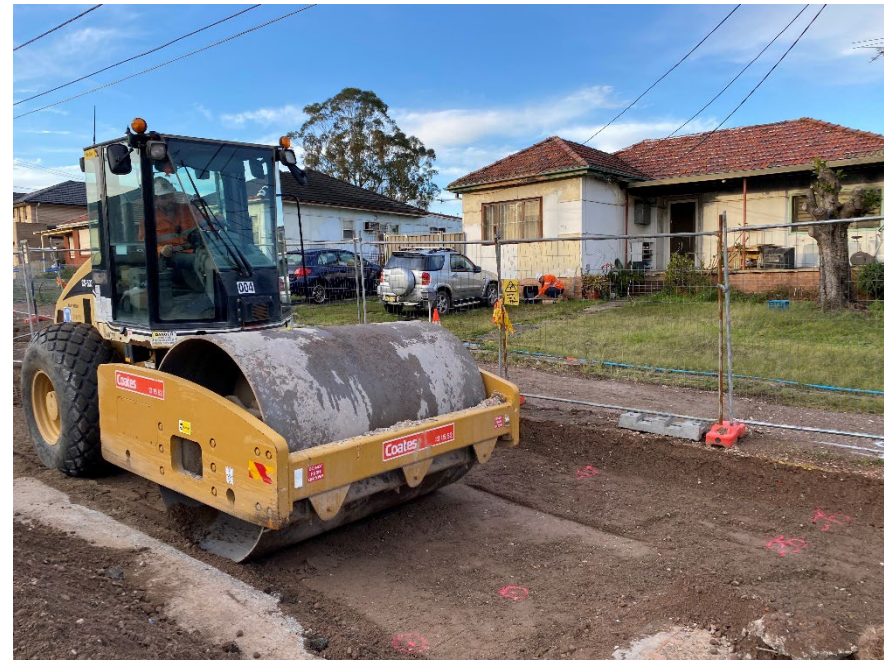
LOCATION: 168 Broomfield Street, Cabramatta

Above: Monitoring of 12T vibration roller at 168 Broomfield St on the 12th July 2022.

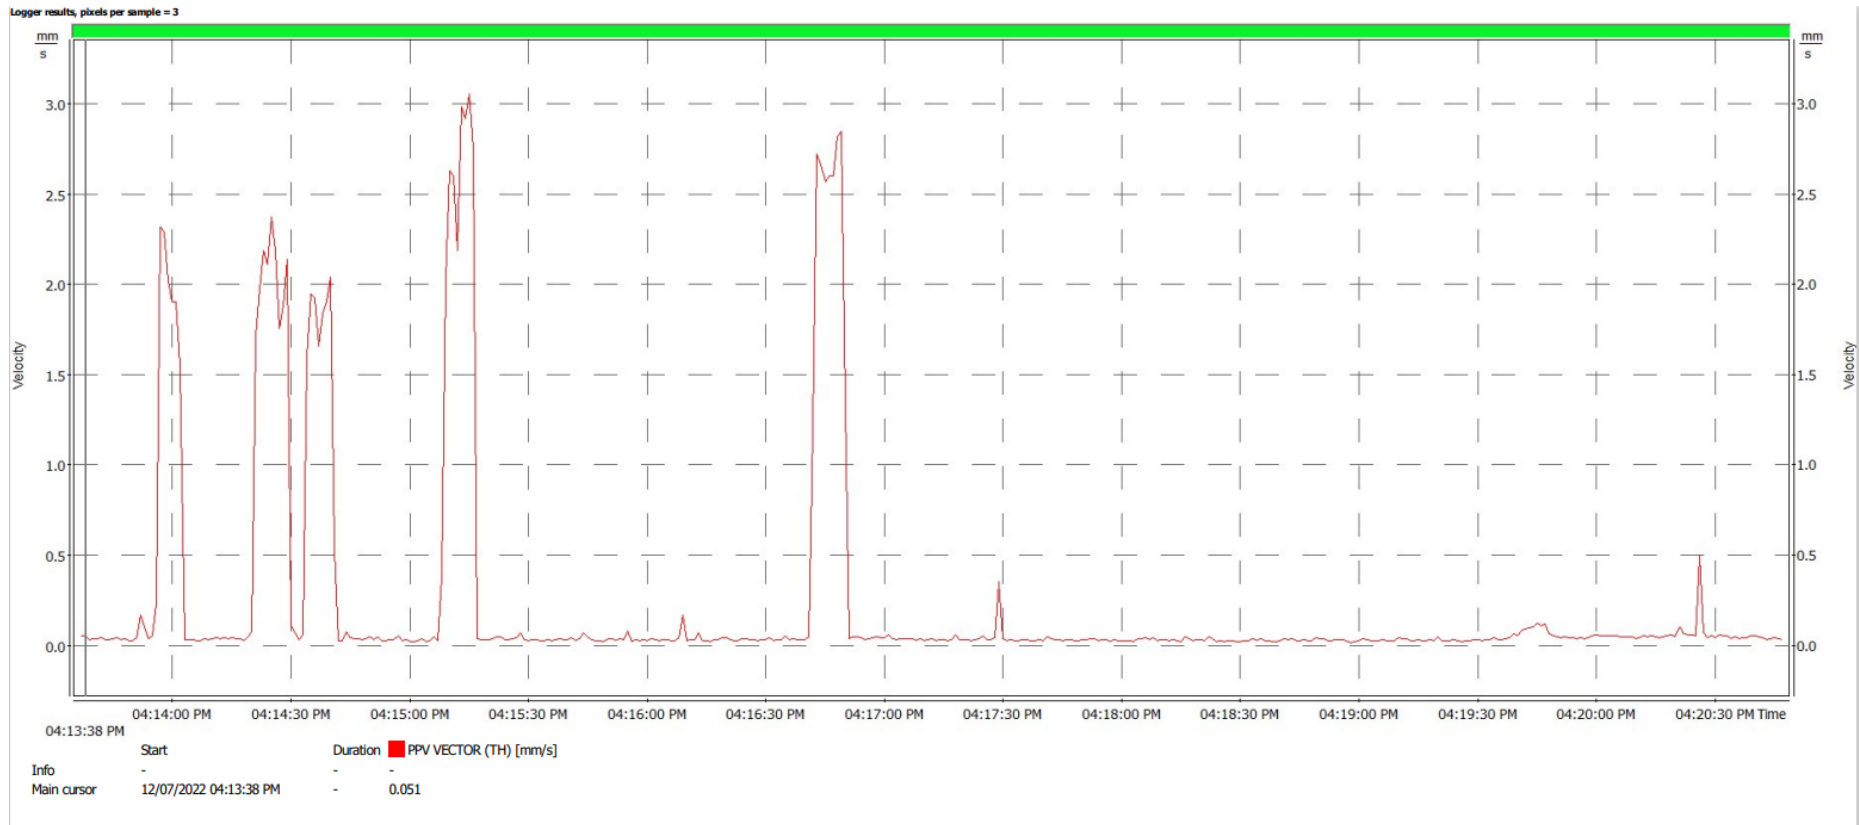
Above: Results from monitoring at residential property in Broomfield St. The peak velocity reached 3mm/s during maximum vibration.

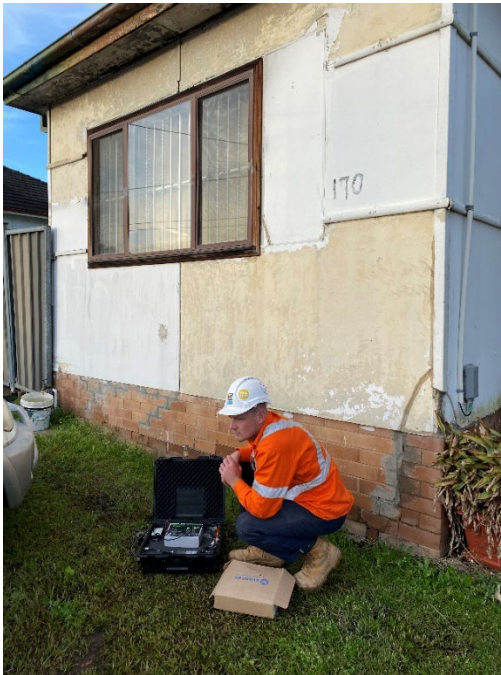
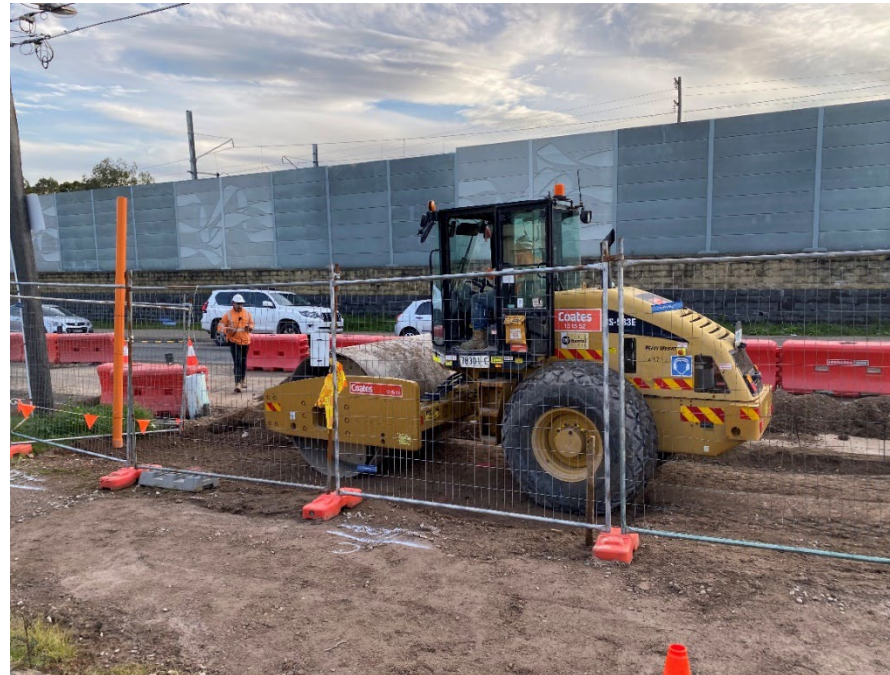
LOCATION: 170 Broomfield Street, Cabramatta

Above: Monitoring at 170 Broomfield St on July 12th 2022 during compaction rolling.

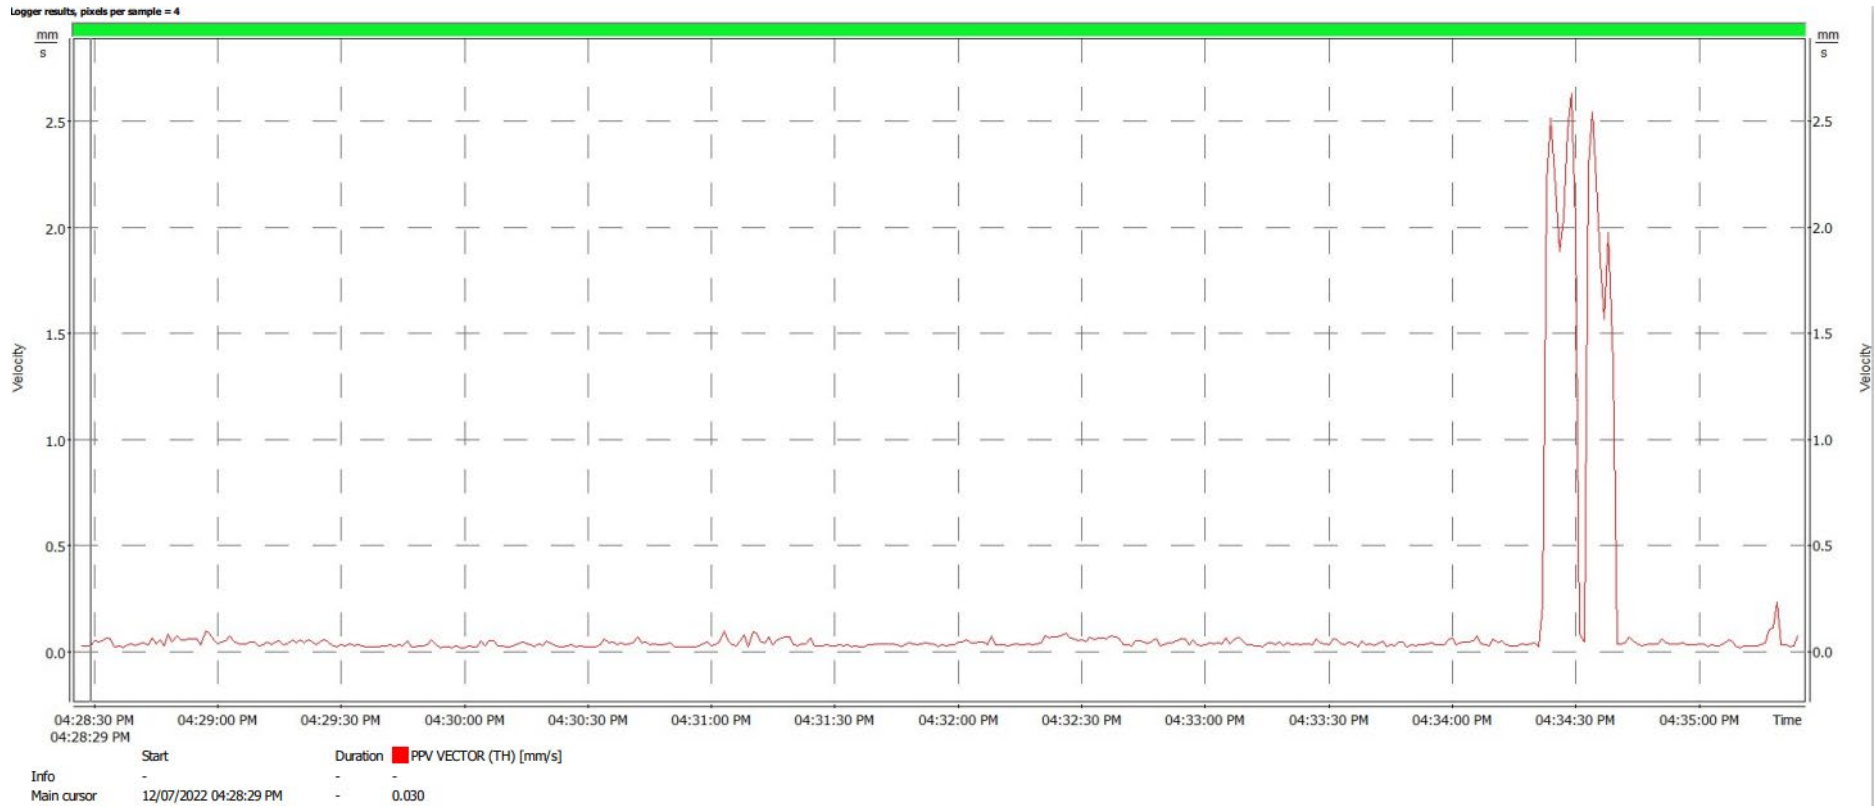
Above: Monitoring results from 170 Broomfield Street on the 12th July 2022. Vibration peaked at 2.5mm/s.

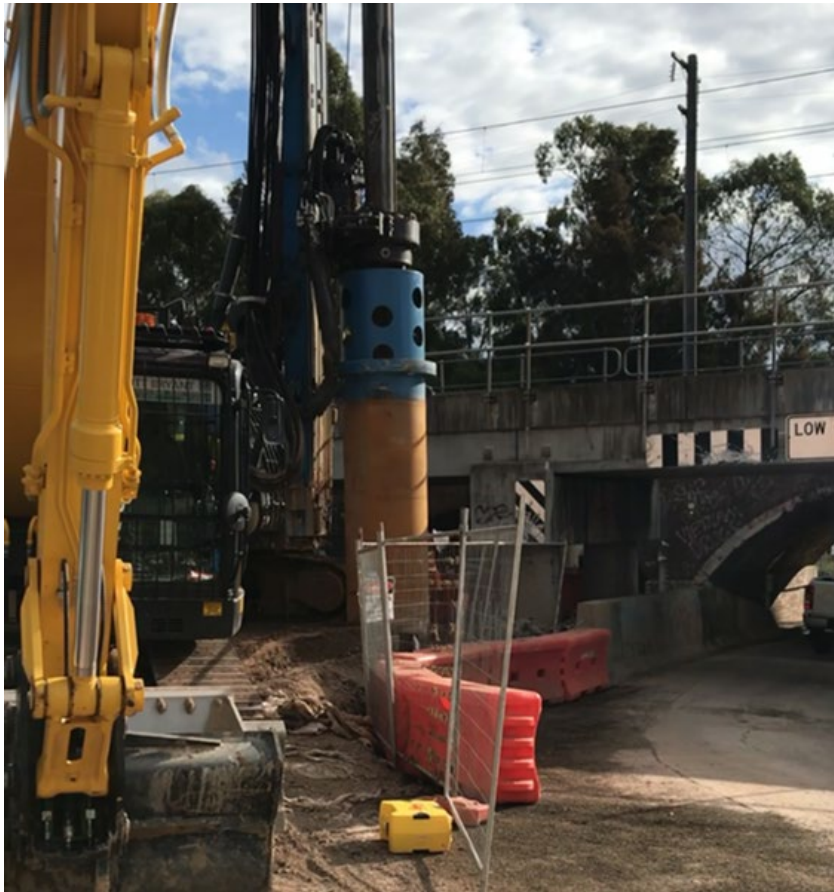
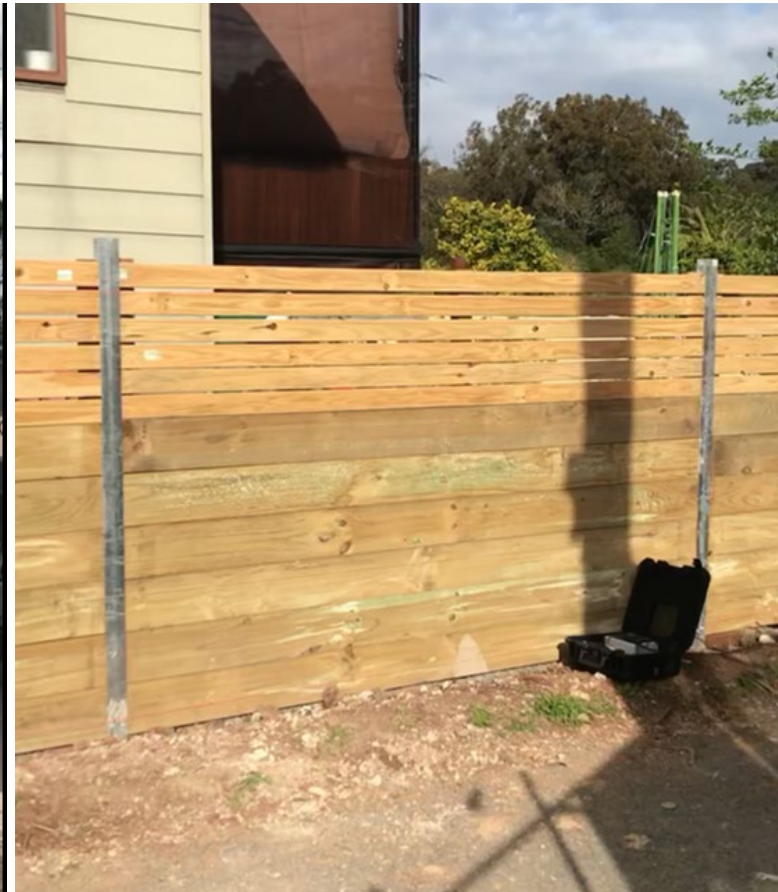
LOCATION: 10 Sussex Street, Cabramatta

ACTIVITY: Piling for Sussex Street bridge – 26th August 2022

Above: Attended monitoring results of piling at Sussex Street bridge on the 26th August 2022. Velocity peaked at 0.35mm/s.

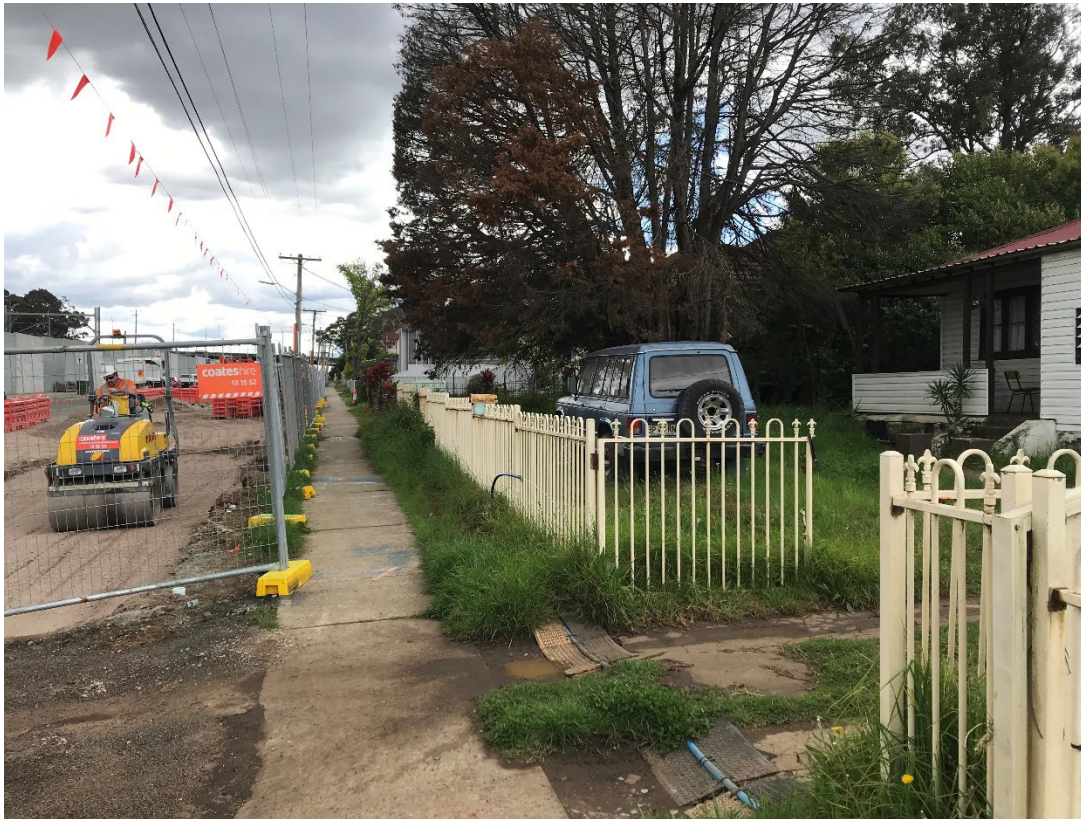
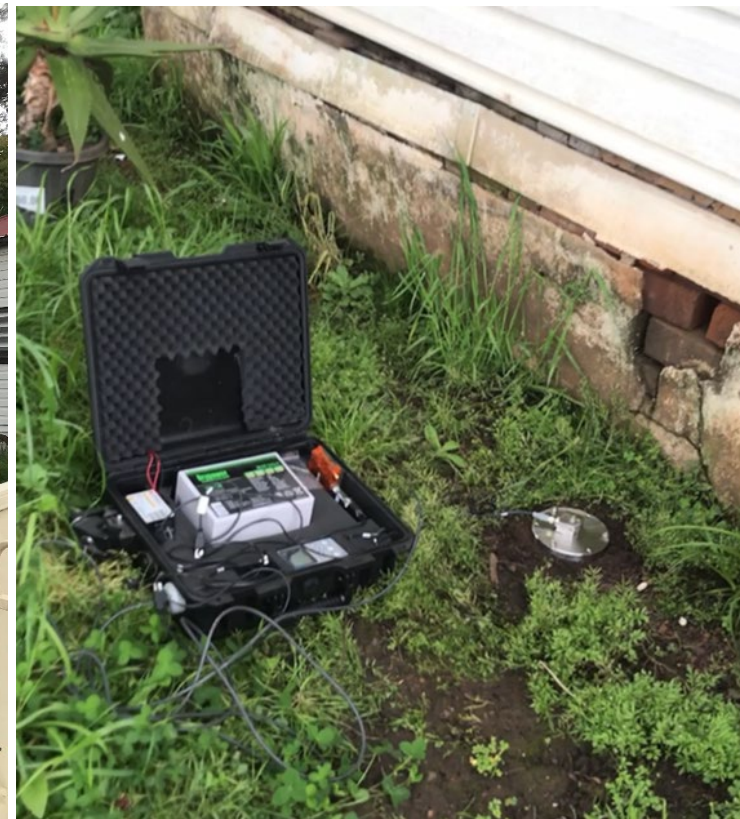
LOCATION: 124 Broomfield Street, Cabramatta

ACTIVITY: Compaction of backfill material using 6T roller (Stage 2 works) – 5th September 2022

Above: Attended monitoring results of compaction rolling at 124 Broomfield Street on the 5th of September 2022. Velocity peaked at ~3.4mm/s during monitoring.
